DEPARTMENT OF TRANSPORTATION

Contract #: 04-0120F4Cty: SF/ALA Rte: 80 PM: 13.2/13.9File #: 69.28**WELDING INSPECTION REPORT****Resident Engineer:** Siegenthaler, Peter**Address:** 333 Burma Road**City:** Oakland, CA 94607**Report No:** WIR-016950**Date Inspected:** 09-Sep-2010**Project Name:** SAS Superstructure**OSM Arrival Time:** 700**Prime Contractor:** American Bridge/Fluor Enterprises, a JV**OSM Departure Time:** 1900**Contractor:** Zhenhua Port Machinery Company, Ltd (ZPMC), Changxing Island **Location:** Shanghai, China

Bridge No: 34-0006**Component:** Tower & OBG Components**Summary of Items Observed:**

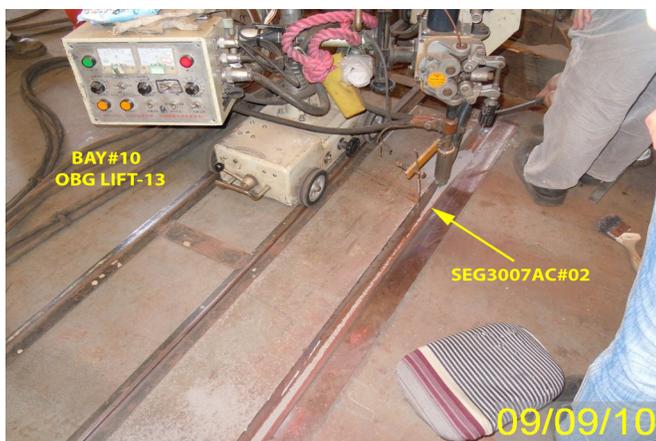
Weld joint # 02 located on SEG3007AC. Welder is identified as 058100. ZPMC Quality Control (QC) Inspector is identified as Zhang Lin. The welding variables recorded by QC appeared to comply with the WPS – B – T – 2221 – B – U3c – S – 2. (See attached photo)

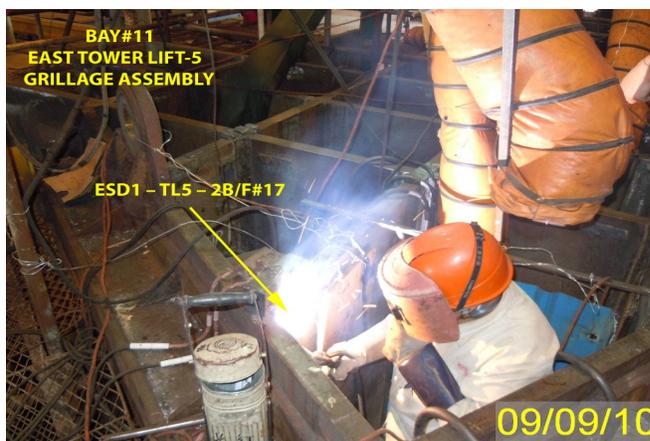
Weld joint # 17 located on East tower Lift-5 Grillage Assembly ESD1 – TL5 – 2B/F. Welder is identified as 040611. ZPMC Quality Control (QC) Inspector is identified as Shang Hai Long. The welding variables recorded by QC appeared to comply with the WPS – B – T – 3213 – Tc – U4c. (See attached photo)
