**DEPARTMENT OF TRANSPORTATION**

Contract #: 04-0120F4Cty: SF/Ala Rte: 80 PM: 13.2/13.9File #: 69.28**WELDING INSPECTION REPORT****Resident Engineer:** Siegenthaler, Peter**Address:** 333 Burma Road**City:** Oakland, CA 94607**Report No:** WIR-016952**Date Inspected:** 15-Sep-2010**Project Name:** SAS Superstructure**OSM Arrival Time:** 1900**Prime Contractor:** American Bridge/Fluor Enterprises, a JV**OSM Departure Time:** 700**Contractor:** Zhenhua Port Machinery Company, Ltd (ZPMC), Changxing Island **Location:** Shanghai, China**CWI Name:** See below**CWI Present:** Yes No**Inspected CWI report:** Yes No N/A**Rod Oven in Use:** Yes No N/A**Electrode to specification:** Yes No N/A**Weld Procedures Followed:** Yes No N/A**Qualified Welders:** Yes No N/A**Verified Joint Fit-up:** Yes No N/A**Approved Drawings:** Yes No N/A**Approved WPS:** Yes No N/A**Delayed / Cancelled:** Yes No N/A**Bridge No:** 34-0006**Component:** Tower and OBG Components**Summary of Items Observed:**

# WELDING INSPECTION REPORT

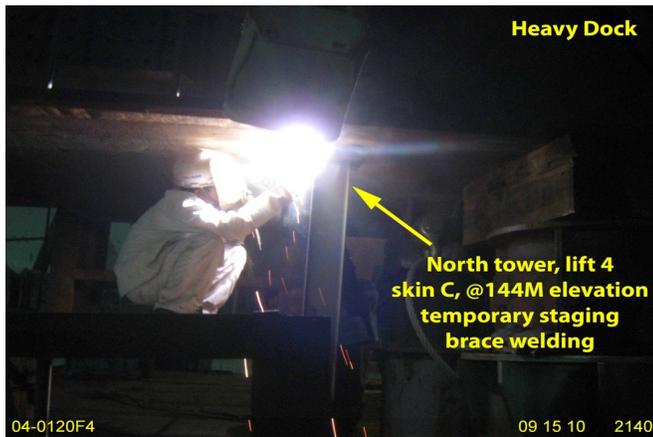
SMAW welding of temporary staging brace located on PCMK north tower, lift 4, skin C, at approximately 144M elevation as the segment was positioned horizontally on the deck of the dock. See photo below. Welders were identified as 040365, 052910. QC was identified as ZPMC CWI Zhao Chen Sun (QC3). Welding variables recorded by QC3 appeared to comply with WPS-B-P-4114.
