DEPARTMENT OF TRANSPORTATION

Contract #: 04-0120F4Cty: SF/ALA Rte: 80 PM: 13.2/13.9File #: 69.28**WELDING INSPECTION REPORT****Resident Engineer:** Siegenthaler, Peter**Address:** 333 Burma Road**City:** Oakland, CA 94607**Report No:** WIR-016960**Date Inspected:** 14-Sep-2010**Project Name:** SAS Superstructure**OSM Arrival Time:** 700**Prime Contractor:** American Bridge/Fluor Enterprises, a JV**OSM Departure Time:** 1900**Contractor:** Zhenhua Port Machinery Company, Ltd (ZPMC), Changxing Island **Location:** Shanghai, China**CWI Name:** Qiu Wen**CWI Present:** Yes No**Inspected CWI report:** Yes No N/A**Rod Oven in Use:** Yes No N/A**Electrode to specification:** Yes No N/A**Weld Procedures Followed:** Yes No N/A**Qualified Welders:** Yes No N/A**Verified Joint Fit-up:** Yes No N/A**Approved Drawings:** Yes No N/A**Approved WPS:** Yes No N/A**Delayed / Cancelled:** Yes No N/A**Bridge No:** 34-0006**Component:** Tower & OBG Components**Summary of Items Observed:**

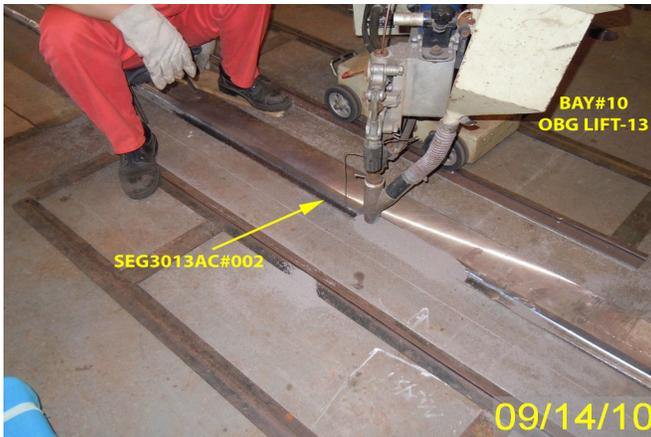
Weld joint # 002 located on SEG3013AC. Welder is identified as 045240. ZPMC Quality Control (QC) Inspector is identified as Guo Wei. The welding variables recorded by QC appeared to comply with the WPS – B – T – 2221 – B – U3c – S – 2. (See attached photo)

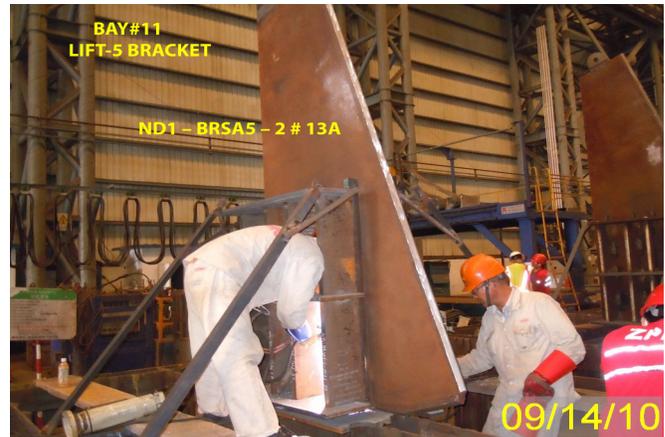
Weld joint # 13A located on Lift-5 Bracket ND1 – BRSA5 – 2. Welder is identified as 054460. ZPMC Quality Control (QC) Inspector is identified as Zhao Mao Mao. The welding variables recorded by QC appeared to comply with the WPS – B – T – 3213 – Tc – U4b. (See attached photo)
