Contract #: 04-0120F4Cty: SF/ALA Rte: 80 PM: 13.2/13.9File #: 69.28**WELDING INSPECTION REPORT****Resident Engineer:** Siegenthaler, Peter**Address:** 333 Burma Road**City:** Oakland, CA 94607**Report No:** WIR-016962**Date Inspected:** 21-Sep-2010**Project Name:** SAS Superstructure**OSM Arrival Time:** 700**Prime Contractor:** American Bridge/Fluor Enterprises, a JV**OSM Departure Time:** 1900**Contractor:** Zhenhua Port Machinery Company, Ltd (ZPMC), Changxing Island **Location:** Shanghai, China**CWI Name:** Mr. Xu Le Fung.**CWI Present:** Yes No**Inspected CWI report:** Yes No N/A**Rod Oven in Use:** Yes No N/A**Electrode to specification:** Yes No N/A**Weld Procedures Followed:** Yes No N/A**Qualified Welders:** Yes No N/A**Verified Joint Fit-up:** Yes No N/A**Approved Drawings:** Yes No N/A**Approved WPS:** Yes No N/A**Delayed / Cancelled:** Yes No N/A**Bridge No:** 34-0006**Component:** Tower and Orthotropic Box Girder (OBG)**Summary of Items Observed:**

WELDING INSPECTION REPORT

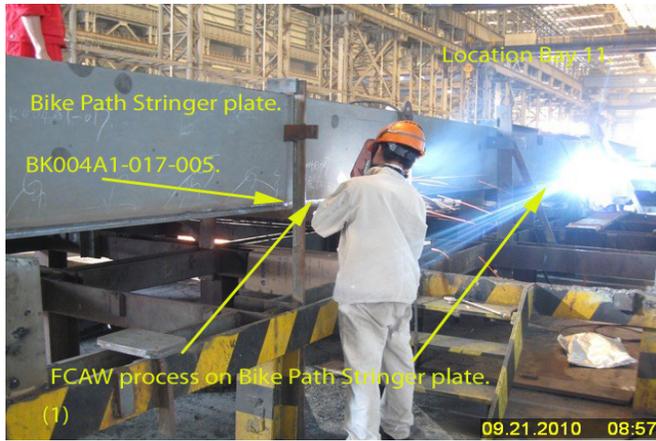
This QA Inspector observed ZPMC qualified welding personnel identified as 040759, 053316, Perform Flux Core Arc Welding (FCAW) on OBG bike path stringer plate. Joint identified as BK004A-017-005. ZPMC QC

Identified as Wang Chang Xin. The welding parameters as measured using QC's calibrated instrument appeared to be in general compliance with WPS-B-T-2232-Tc-U4c-F. For more information see below attached picture number 1.

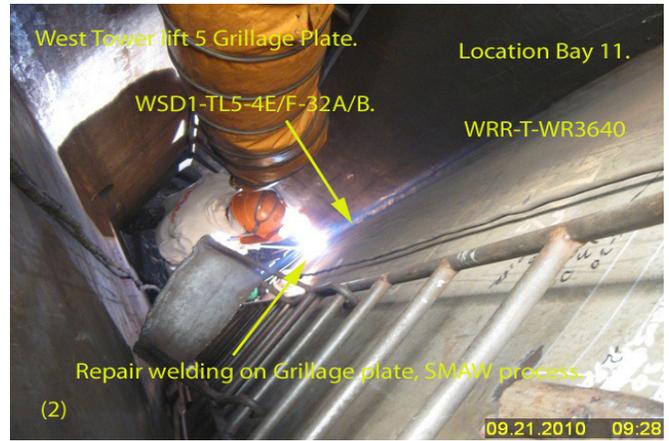
This QA Inspector observed ZPMC qualified welding personnel identified as 037743 Perform Shielded Metal Arc Welding (SMAW) on West tower lift 5 Grillage plate. Joint identified as WSD1-TL5-4E/F-32A/B. ZPMC QC Identified as Xu Jie with temporary welding repair report WRR-T-WR3640. The welding parameters as measured using QC's calibrated instrument appeared to be in general compliance with WPS-485-SMAW-3G (3F) Repair. For more information see below attached picture number 2.

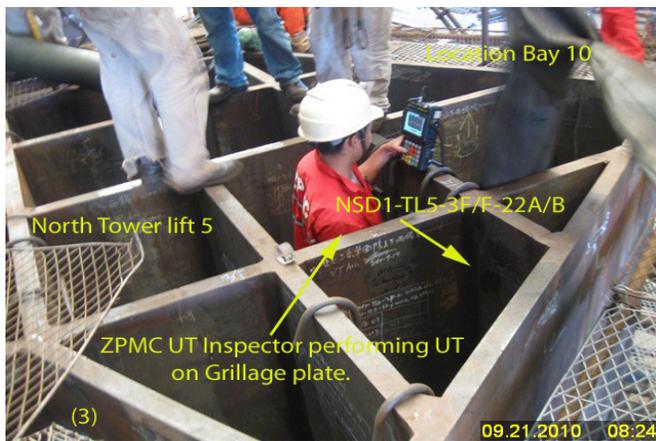
This QA Inspector observed ZPMC Ultrasonic Testing Inspector, performing UT on North Tower lift 5 Grillage plate. Joint identified as NSD1-TL5-3F-F-22A/B. For more information see below attached picture number 3.
