**DEPARTMENT OF TRANSPORTATION**

Contract #: 04-0120F4Cty: SF/ALA Rte: 80 PM: 13.2/13.9File #: 69.28**WELDING INSPECTION REPORT****Resident Engineer:** Siegenthaler, Peter**Address:** 333 Burma Road**City:** Oakland, CA 94607**Report No:** WIR-016967**Date Inspected:** 17-Sep-2010**Project Name:** SAS Superstructure**OSM Arrival Time:** 700**Prime Contractor:** American Bridge/Fluor Enterprises, a JV**OSM Departure Time:** 1900**Contractor:** Zhenhua Port Machinery Company, Ltd (ZPMC), Changxing Island **Location:** Shanghai, China**CWI Name:** Xu Le Feng**CWI Present:** Yes No**Inspected CWI report:** Yes No N/A**Rod Oven in Use:** Yes No N/A**Electrode to specification:** Yes No N/A**Weld Procedures Followed:** Yes No N/A**Qualified Welders:** Yes No N/A**Verified Joint Fit-up:** Yes No N/A**Approved Drawings:** Yes No N/A**Approved WPS:** Yes No N/A**Delayed / Cancelled:** Yes No N/A**Bridge No:** 34-0006**Component:** Tower Components**Summary of Items Observed:**

## WELDING INSPECTION REPORT

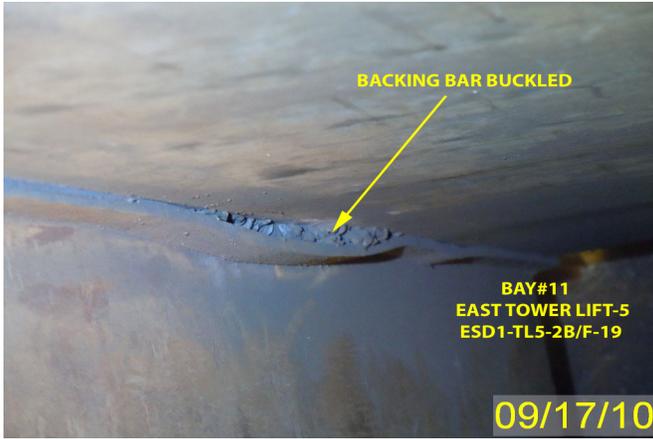
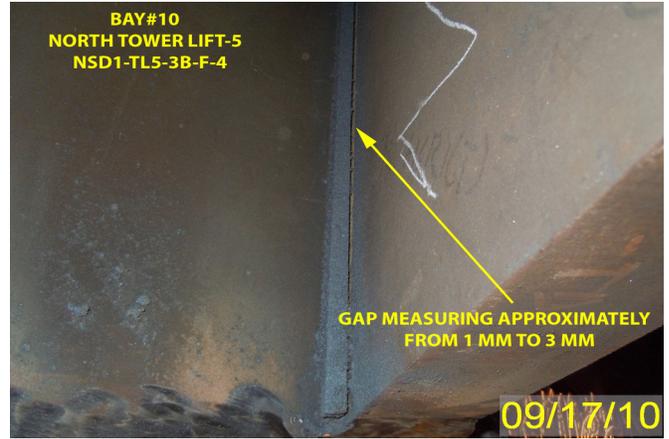
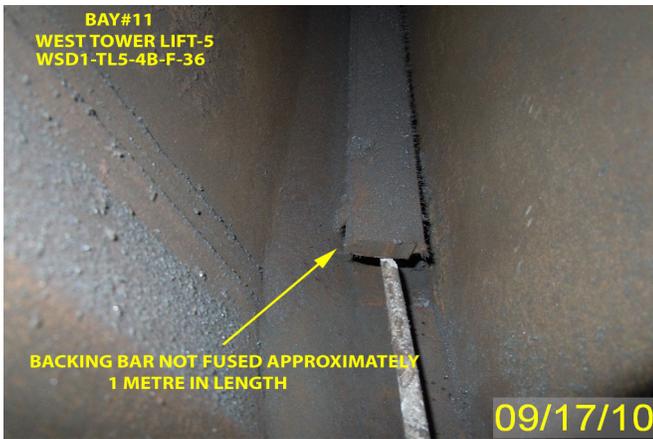
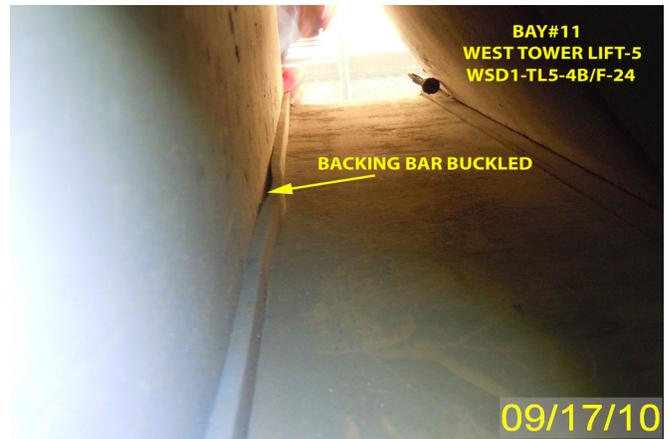
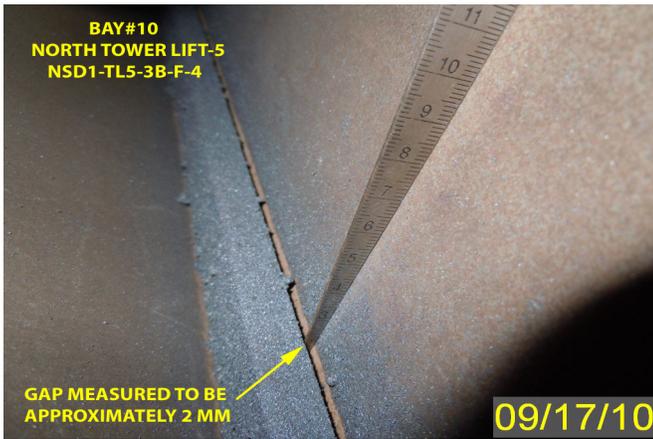
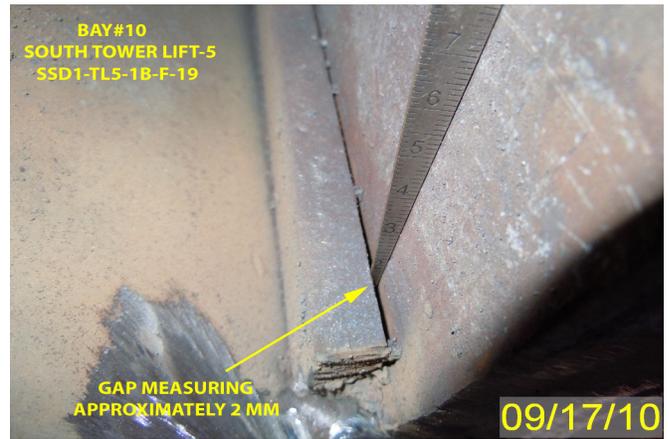
During survey the following discrepancies found on lift-5 tower shafts: -

1. SOUTH TOWER LIFT-5: Found gap from 1mm to 2mm (SSD1-TL5-1B-F#19)
2. NORTH TOWER LIFT-5: Found gap from 1mm to 3mm (NSD1-TL5-3B-F#4)
3. EAST TOWER LIFT-5: Found gap from 1mm to 2mm (ESD1-TL5-2B-F#13)
4. EAST TOWER LIFT-5: Found gap from 1mm to 2mm (ESD1-TL5-2B-F#14)
5. EAST TOWER LIFT-5: Buckled (ESD1-TL5-2B-F#19)
6. WEST TOWER LIFT-5: Found gap from 1mm to 2mm (WSD1-TL5-4B-F#23)
7. WEST TOWER LIFT-5: Found gap from 1mm to 2mm (WSD1-TL5-4B-F#3)
8. WEST TOWER LIFT-5: Found gap from 1mm to 2mm (WSD1-TL5-4B-F#35)
9. WEST TOWER LIFT-5: Buckled (WSD1-TL5-4B-F#24)
10. WEST TOWER LIFT-5: Not fused approximately 1 metre in length (WSD1-TL5-4B-F#36)
