DEPARTMENT OF TRANSPORTATION

Quality Assurance and Source Inspection

Contract #: 04-0120F4Cty: SF/ALA Rte: 80 PM: 13.2/13.9File #: 69.28**WELDING INSPECTION REPORT****Resident Engineer:** Siegenthaler, Peter**Address:** 333 Burma Road**City:** Oakland, CA 94607**Report No:** WIR-016970**Date Inspected:** 21-Sep-2010**Project Name:** SAS Superstructure**OSM Arrival Time:** 700**Prime Contractor:** American Bridge/Fluor Enterprises, a JV**OSM Departure Time:** 1900**Contractor:** Zhenhua Port Machinery Company, Ltd (ZPMC), Changxing Island **Location:** Shanghai, China**CWI Name:** Qiu Wen**CWI Present:** Yes No**Inspected CWI report:** Yes No N/A**Rod Oven in Use:** Yes No N/A**Electrode to specification:** Yes No N/A**Weld Procedures Followed:** Yes No N/A**Qualified Welders:** Yes No N/A**Verified Joint Fit-up:** Yes No N/A**Approved Drawings:** Yes No N/A**Approved WPS:** Yes No N/A**Delayed / Cancelled:** Yes No N/A**Bridge No:** 34-0006**Component:** Tower & OBG Components**Summary of Items Observed:**

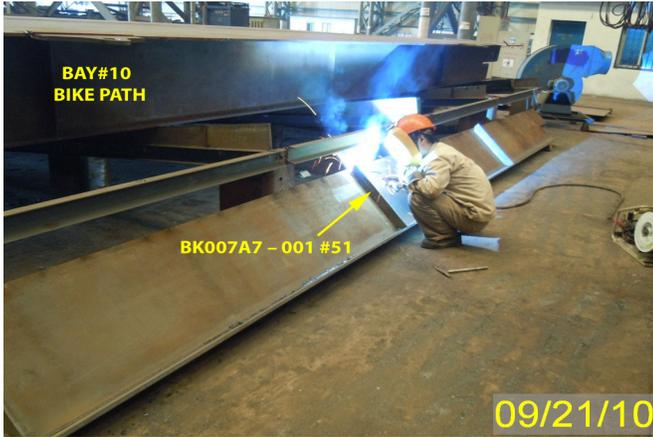
Weld joint # 51 located on Bike Path BK007A7 – 001. Welder is identified as 052075. ZPMC Quality Control (QC) Inspector is identified as Ma Qian Li. The welding variables recorded by QC appeared to comply with the WPS – B – T – 2133. (See attached photo)

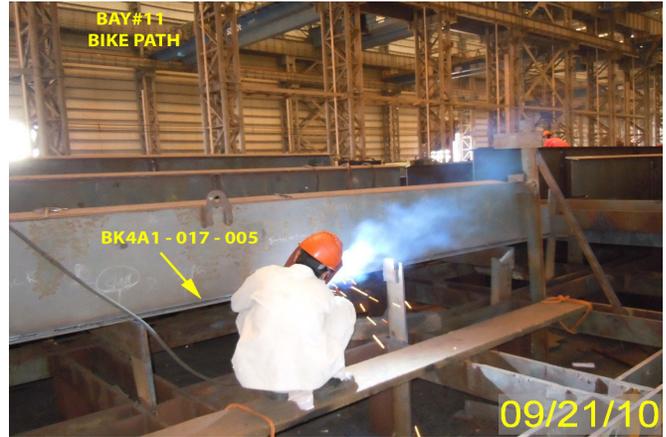
Weld joint # 005 located on Bike Path BK004A1 – 017. Welder is identified as 040759. ZPMC Quality Control

(QC) Inspector is identified as Wang Chuang Xin. The welding variables recorded by QC appeared to comply with the WPS – B – T – 2232 – Tc – U4c – F. (see attached photo)
