DEPARTMENT OF TRANSPORTATION

Office of Structural Materials

Contract #: 04-0120F4Cty: SF/ALA Rte: 80 PM: 13.2/13.9File #: 69.28**WELDING INSPECTION REPORT****Resident Engineer:** Siegenthaler, Peter**Address:** 333 Burma Road**City:** Oakland, CA 94607**Report No:** WIR-016971**Date Inspected:** 22-Sep-2010**Project Name:** SAS Superstructure**OSM Arrival Time:** 700**Prime Contractor:** American Bridge/Fluor Enterprises, a JV**OSM Departure Time:** 1900**Contractor:** Zhenhua Port Machinery Company, Ltd (ZPMC), Changxing Island **Location:** Shanghai, China**CWI Name:** Qiu Wen**CWI Present:** Yes No**Inspected CWI report:** Yes No N/A**Rod Oven in Use:** Yes No N/A**Electrode to specification:** Yes No N/A**Weld Procedures Followed:** Yes No N/A**Qualified Welders:** Yes No N/A**Verified Joint Fit-up:** Yes No N/A**Approved Drawings:** Yes No N/A**Approved WPS:** Yes No N/A**Delayed / Cancelled:** Yes No N/A**Bridge No:** 34-0006**Component:** Tower & OBG Components**Summary of Items Observed:**

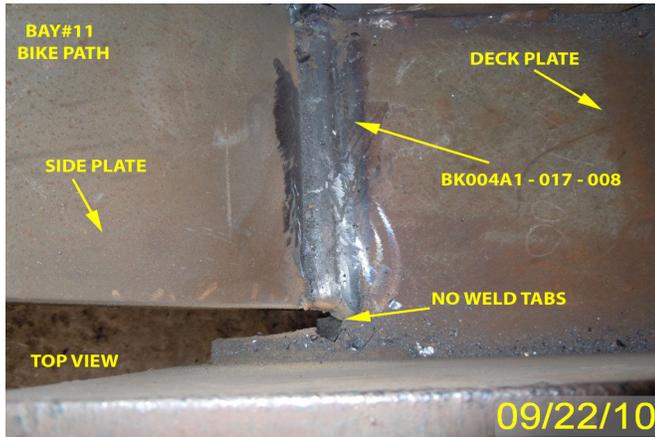
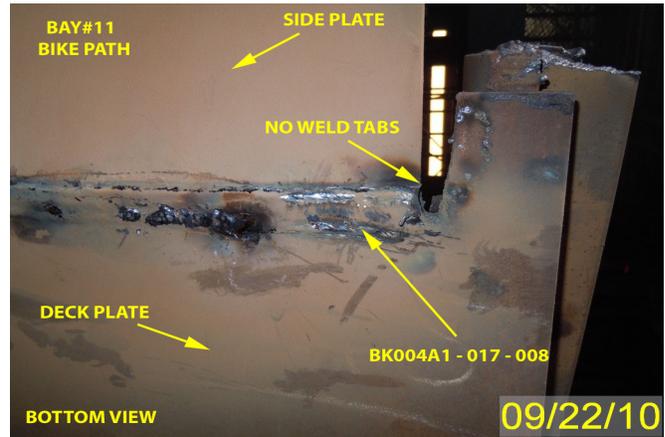
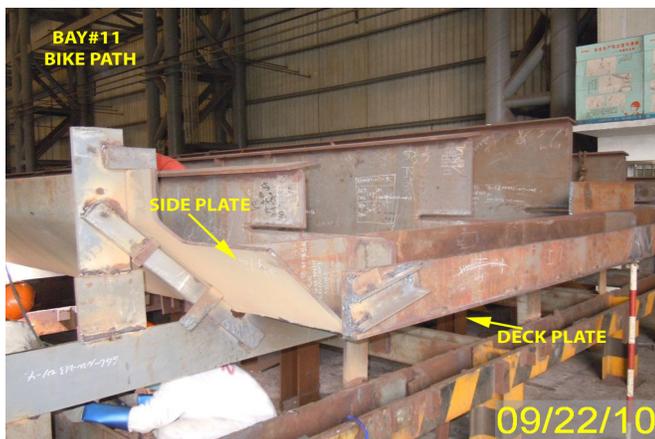
-ZPMC personnel performed welding of CJP butt weld joint on Bike Path BK004A-017, without using the weld tabs at both ends.

-The weld is a complete joint penetration (CJP) Butt joint, joining the Bike Path side plate (BKPL3B) to the Top Plate (BKPL2A).

-The weld is identified as BK004A1 – 017 # 008.

3.12.1 “Welds shall be terminated at the end of a joint in a manner that will ensure sound welds. Whenever possible, this shall be done by use of weld tabs (extension bars and runoff plates) placed in a manner that will duplicate the joint detail being welded.”
