**DEPARTMENT OF TRANSPORTATION**

Office of Structural Materials

## WELDING INSPECTION REPORT

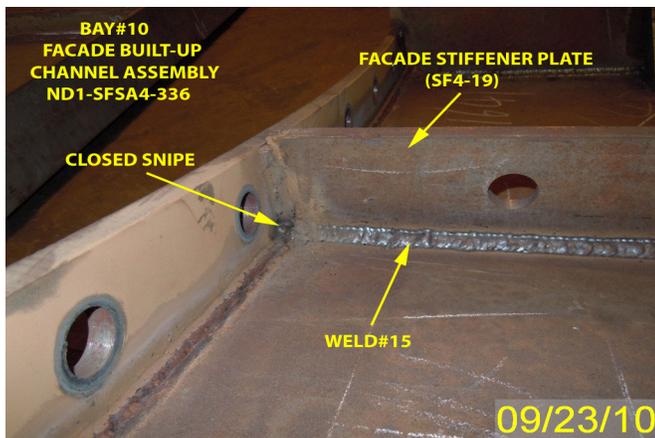
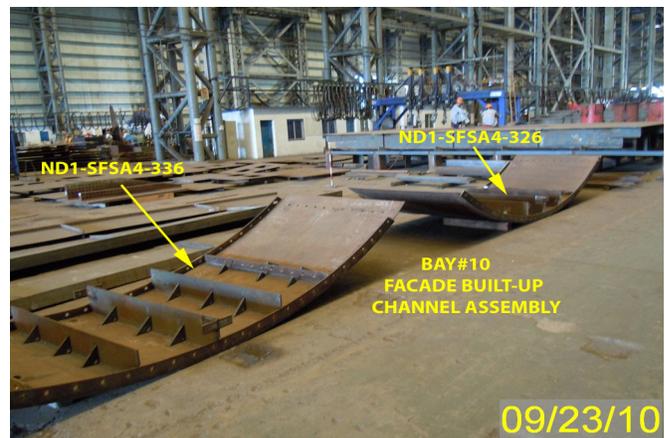
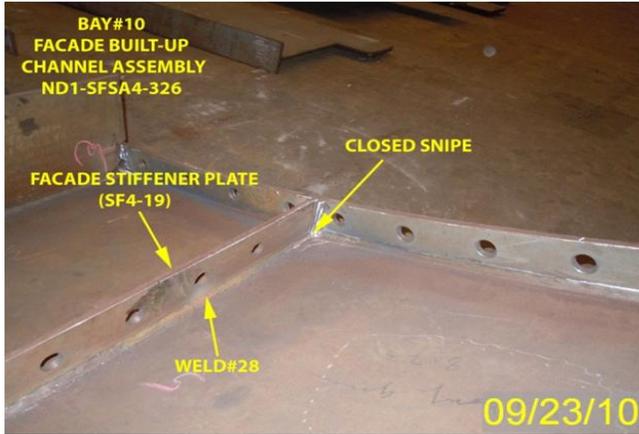
During the Caltrans Quality Assurance (QA) in-process observations of the fabrication of Façade built-up channel Assembly, this QA Inspector discovered the following issues:

-Stiffeners' snipes were closed by welding.

- 1) NSD1-SFSA4-336; 131 M – Closed snipes on two (2) façade stiffener plates (SF4-19).
- 2) NSD1-SFSA4-326; 143 M – Closed snipes on two (2) façade stiffener plates (SF4-19).

- Façade stiffener plates (SF4-19) were fabricated with snipes shown in the approved shop drawings.
