DEPARTMENT OF TRANSPORTATION

Contract #: 04-0120F4Cty: SF/ALA Rte: 80 PM: 13.2/13.9File #: 69.28**WELDING INSPECTION REPORT****Resident Engineer:** Siegenthaler, Peter**Address:** 333 Burma Road**City:** Oakland, CA 94607**Report No:** WIR-016993**Date Inspected:** 03-Sep-2010**Project Name:** SAS Superstructure**OSM Arrival Time:** 1900**Prime Contractor:** American Bridge/Fluor Enterprises, a JV**OSM Departure Time:** 700**Contractor:** Zhenhua Port Machinery Company, Ltd (ZPMC), Changxing Island **Location:** Shanghai, China**CWI Name:** See Below**CWI Present:** Yes No**Inspected CWI report:** Yes No N/A**Rod Oven in Use:** Yes No N/A**Electrode to specification:** Yes No N/A**Weld Procedures Followed:** Yes No N/A**Qualified Welders:** Yes No N/A**Verified Joint Fit-up:** Yes No N/A**Approved Drawings:** Yes No N/A**Approved WPS:** Yes No N/A**Delayed / Cancelled:** Yes No N/A**Bridge No:** 34-0006**Component:** OBG**Summary of Items Observed:**

OBG Segment Trial Assembly

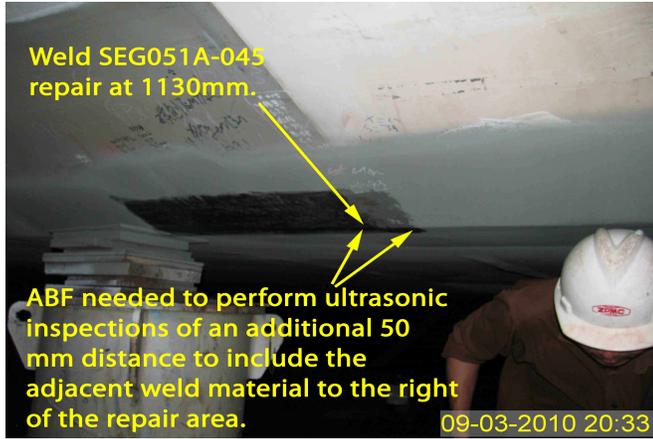
ABF issued "Inspection Notification Sheet" number 09022010-2 item #1 informing QA that on 09-03-2010 at 1940 hours ABF Inspectors would perform NDE inspections of repaired side plate to bottom plate welds SEG049A-012 and SEG051A-045. These welds join the cross beam side plates to the bottom plates on OBG segments 9AW and 9BW. This QA Inspector observed ABF/Sense Inspectors performing magnetic particle inspection of the weld repair areas where seven UT rejections had previously been repaired. This QA Inspector observed ABF/Sense Inspectors performing ultrasonic inspections of these same areas and ABF Inspectors informed this QA Inspector that all seven repair areas were accepted. This QA Inspector used a tape measure to confirm the location of each of these seven repair areas and this QA Inspector observed that the weld repair location at 1130mm was located at the very end of the area where the paint had been removed. AWS D1.5 paragraph 6.7.3 states: After repairs of discontinuities have been made, additional NDT inspection shall be performed to ensure that the repairs are satisfactory. This testing shall include the repaired area plus at least 50 mm [2 in.] on each side of the repaired area. This QA Inspector showed ABF NDE Inspectors that weld repair

location at 1130mm had not been inspected for an additional 50 mm in the direction of OBG segment 9CW. See the photograph below for additional information. ABF initially started to perform UT inspections of this area through the painted surface and after the paint had been ground off, ABF performed NDE inspections of location 1130 mm for an additional 100 mm distance. This QA Inspector performed random visual and ultrasonic inspections utilizing scanning patterns A, B, C and D (AWS D1.5 Fig 6.7) and all seven areas that were randomly inspected appeared to comply with project specifications. Note: These inspections were documented and tracked on "Verification Witness Request" documents. See the TL-6027 UT report for additional information concerning this inspection.
