**DEPARTMENT OF TRANSPORTATION**

Contract #: 04-0120F4Cty: SF/ALA Rte: 80 PM: 13.2/13.9File #: 1.28**WELDING INSPECTION REPORT****Resident Engineer:** Siegenthaler, Peter**Address:** 333 Burma Road**City:** Oakland, CA 94607**Report No:** WIR-016996**Date Inspected:** 25-Sep-2010**Project Name:** SAS Superstructure**OSM Arrival Time:** 630**Prime Contractor:** American Bridge/Fluor Enterprises, a JV**OSM Departure Time:** 1500**Contractor:** American Bridge/Fluor Enterprises, a JV**Location:** Jobsite**CWI Name:** See below**CWI Present:** Yes No**Inspected CWI report:** Yes No N/A**Rod Oven in Use:** Yes No N/A**Electrode to specification:** Yes No N/A**Weld Procedures Followed:** Yes No N/A**Qualified Welders:** Yes No N/A**Verified Joint Fit-up:** Yes No N/A**Approved Drawings:** Yes No N/A**Approved WPS:** Yes No N/A**Delayed / Cancelled:** Yes No N/A**Bridge No:** 34-0006**Component:** SAS OBG**Summary of Items Observed:**

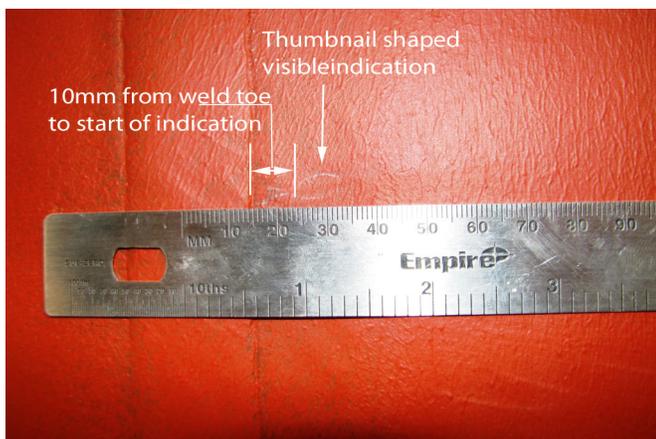
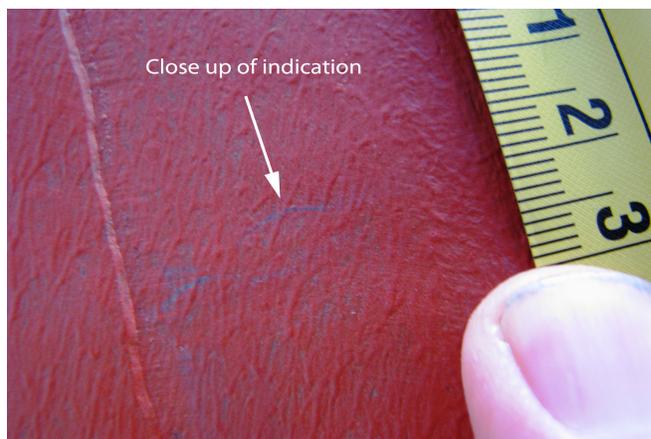
The QAI performed Ultrasonic Testing (UT) and Visual Testing (VT) of a selected area of OBG Field Splice 2E/3E weld ID: E2. The UT and VT examinations were performed to confirm the presence of an exterior surface indication at a location previously tested from the interior surface by METS personnel on 05-06-2010. At the time of the previous testing the METS QA Inspector Mr. Michael Foerder observed what appeared to be an indication possibly associated with the exterior surface of the splice weld, however the scaffolding providing access to the exterior was not present. The QAI during UT of the area on this date observed the same indication from the interior of the OBG. The QAI proceeded to the exterior surface of the same location, physically located and visually observed a surface indication. The surface indication does not appear to be associated with the OBG splice Weld 2E/3E E2. See photos below. The QAI observed that the area in question appears to be in general compliance with contract documents. See Ultrasonic Testing Report Form TL-6027 generated by the QAI on this date for location and results of UT.
