DEPARTMENT OF TRANSPORTATION

Contract #: 04-0120F4Cty: SF/ALA Rte: 80 PM: 13.2/13.9File #: 1.28**WELDING INSPECTION REPORT****Resident Engineer:** Siegenthaler, Peter**Address:** 333 Burma Road**City:** Oakland, CA 94607**Report No:** WIR-017022**Date Inspected:** 27-Sep-2010**Project Name:** SAS Superstructure**OSM Arrival Time:** 1000**Prime Contractor:** American Bridge/Fluor Enterprises, a JV**OSM Departure Time:** 1830**Contractor:** American Bridge/Fluor Enterprises, a JV**Location:** Job Site

Caltrans Office of Structural Material (OSM) Quality Assurance Inspector (QAI) Joselito Lizardo was present at the Self Anchored Suspension (SAS) job site as requested to perform observations on the welding of components for the San Francisco Oakland Bay Bridge (SFOBB) Project.

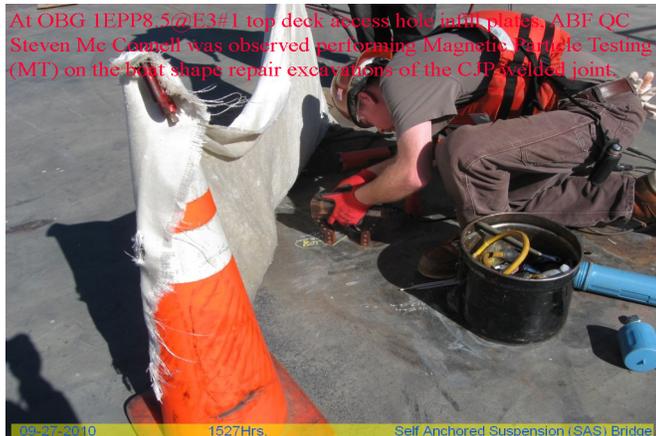
09-27-2010 1527Hrs. Self Anchored Suspension (SAS) Bridge

At 1EPP8.5@E3#1 top deck access hole infill plates, QA randomly observed ABF/JV qualified welder Jin Pei Wang ID #7299 perform CJP groove welding repair. The welder was observed welding in the 1G (flat) position utilizing Shielded metal Arc Welding (SMAW) with 1/8" diameter E7018H4R electrode implementing welding procedure ABF-WPS-D15-1000-Repairs. The repair excavations were preheated to more than 140 degree Fahrenheit using propane gas torch prior welding. During the shift, Steven Mc Connell was noted monitoring the welder. Prior welding, ABF QC Steven Mc Connell was also observed performing Magnetic Particle Testing (MT) using Parker Contour Probe with red magnetic powder as detecting media on the boat shape repair excavations. During the shift, repair welding of the infill plates was still continuing and should remain tomorrow.

At OBG 1EPP8 5@E3#1 top deck access hole (with plates) ABF QC Steven Mc Connell was observed performing Magnetic Particle Testing (MT) on the butt shape repair excavation of the C/P welded joint.

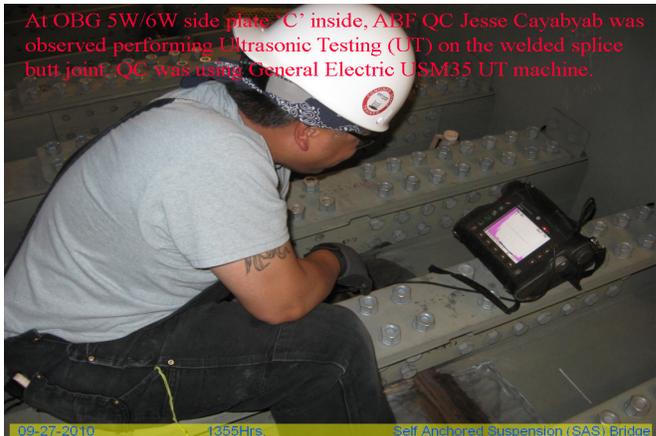
09-27-2010 1558Hrs. Self Anchored Suspension (SAS) Bridge

At OBG 5W/6W side plate 'C' outside, ABF QC Jesse Cayabyab was observed performing Ultrasonic Testing (UT) on the welded splice butt joint. QC was using General Electric USM35 ultrasonic machine. QC was also observed scanning from both sides of face 'A' of the joint. During the shift, QC has completed testing the whole length of the joint and informed QA that he has found 2 rejectable repairs. Since it was already almost quitting time when he finished testing the face 'A' of the joint, he told QA that he will test (UT) the rest of the joint (face 'B') tomorrow.

At OBG 5W/6W side plate 'C' inside, ABF QC Jesse Cayabyab was observed performing Ultrasonic Testing (UT) on the welded splice butt joint. QC was using General Electric UTM35 UT machine.

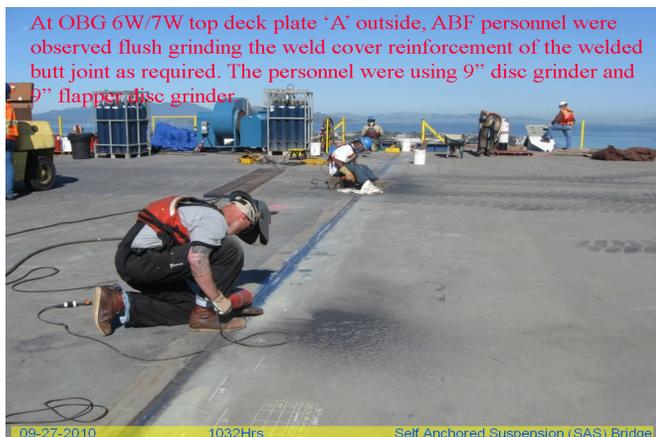
09-27-2010 1032Hrs. Self Anchored Suspension (SAS) Bridge

At OBG 6W/7W top deck plate 'A' outside, three ABF personnel were observed flush grinding the weld cover reinforcement of the splice butt joint as required. The personnel were using the 9" disc grinder followed by 9" flapper with the grinding cut of the discs to the plate parallel to the direction of the bridge complying with the contract requirements. Before the end of the shift, flush grinding of the weld cover reinforcement was completed. Just after the completion of the flush grinding, ABF QC Jim Cunningham was observed performing Magnetic Particle Testing (MT) of the flush ground cover of the welded splice butt joint. QC was using a Magnaflux electromagnetic yoke with red magnetic powder as detecting media. MT was still continuing at the end of the shift and should continue tomorrow.

At OBG 6W/7W top deck plate 'A' outside, ABF personnel were observed flush grinding the weld cover reinforcement of the welded butt joint as required. The personnel were using 9" disc grinder and 9" flap wheel grinder.

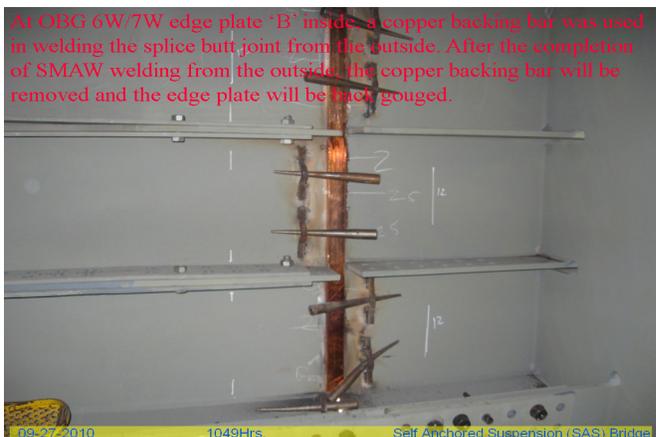
09-27-2010 1049Hrs. Self Anchored Suspension (SAS) Bridge

At OBG 6W/7W edge plate 'B' outside, QA randomly observed ABF/JV qualified welder Yao Xin Liang ID #7238 perform root pass then fill pass on the Complete Joint Penetration (CJP) splice butt joint. The welder was observed manually welding in the 3G (vertical) position utilizing a Shielded Metal Arc Welding (SMAW) with 1/8" diameter E7018H4R electrode and implementing Caltrans approved Welding Procedure Specification (WPS) ABF-WPS-D15-1040B. The joint being welded has a single V-groove butt joint with copper backing bar that will be removed and back gouged. During welding, ABF Quality Control (QC) Jim Cunningham was noted monitoring the welding parameters of the welder. During the shift, fill pass SMAW welding was still continuing and should remain tomorrow.

At OBG 6W/7W edge plate 'B' inside, a copper backing bar was used in welding the splice butt joint from the outside. After the completion of SMAW welding from the outside, the copper backing bar will be removed and the edge plate will be back gouged.
