DEPARTMENT OF TRANSPORTATION

Contract #: 04-0120F4Cty: SF/ALA Rte: 80 PM: 13.2/13.9File #: 1.28**WELDING INSPECTION REPORT****Resident Engineer:** Siegenthaler, Peter**Address:** 333 Burma Road**City:** Oakland, CA 94607**Report No:** WIR-017023**Date Inspected:** 27-Sep-2010**Project Name:** SAS Superstructure**OSM Arrival Time:** 630**Prime Contractor:** American Bridge/Fluor Enterprises, a JV**OSM Departure Time:** 1500**Contractor:** American Bridge/Fluor Enterprises, a JV**Location:** Job Site**CWI Name:** See below**CWI Present:** Yes No**Inspected CWI report:** Yes No N/A**Rod Oven in Use:** Yes No N/A**Electrode to specification:** Yes No N/A**Weld Procedures Followed:** Yes No N/A**Qualified Welders:** Yes No N/A**Verified Joint Fit-up:** Yes No N/A**Approved Drawings:** Yes No N/A**Approved WPS:** Yes No N/A**Delayed / Cancelled:** Yes No N/A**Bridge No:** 34-0006**Component:** SAS OBG**Summary of Items Observed:**

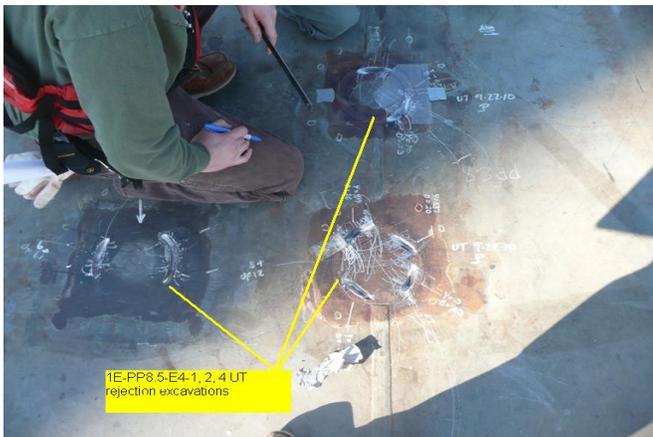
The QA Inspector randomly observed two ABF representatives performing grinding tasks ultrasonic testing rejects in the above identified lifting lug deck hole restoration. The QA Inspector noted no welding was performed only excavations of previously tested welds.

The QA Inspector performed a job walk of the East and West bound bridge decks and updated the QA NDT and production log book and chart. In addition the QA Inspector updated and generated a QA NDT spreadsheet and production checklist for the in process production welding and repairs of the top deck plate lifting lug hole restoration.
