Contract #: 04-0120F4Cty: SF/ALA Rte: 80 PM: 13.2/13.9File #: 69.28**WELDING INSPECTION REPORT****Resident Engineer:** Siegenthaler, Peter**Address:** 333 Burma Road**City:** Oakland, CA 94607**Report No:** WIR-017055**Date Inspected:** 25-Sep-2010**Project Name:** SAS Superstructure**OSM Arrival Time:** 700**Prime Contractor:** American Bridge/Fluor Enterprises, a JV**OSM Departure Time:** 1900**Contractor:** Zhenhua Port Machinery Company, Ltd (ZPMC), Changxing Island **Location:** Shanghai, China**CWI Name:** Yu Dong Ping, Qiu Wen**CWI Present:** Yes No**Inspected CWI report:** Yes No N/A**Rod Oven in Use:** Yes No N/A**Electrode to specification:** Yes No N/A**Weld Procedures Followed:** Yes No N/A**Qualified Welders:** Yes No N/A**Verified Joint Fit-up:** Yes No N/A**Approved Drawings:** Yes No N/A**Approved WPS:** Yes No N/A**Delayed / Cancelled:** Yes No N/A**Bridge No:** 34-0006**Component:** OBG/TOWER**Summary of Items Observed:**

BAY 11, OBG BIKE PATH (NWIT # 06762)

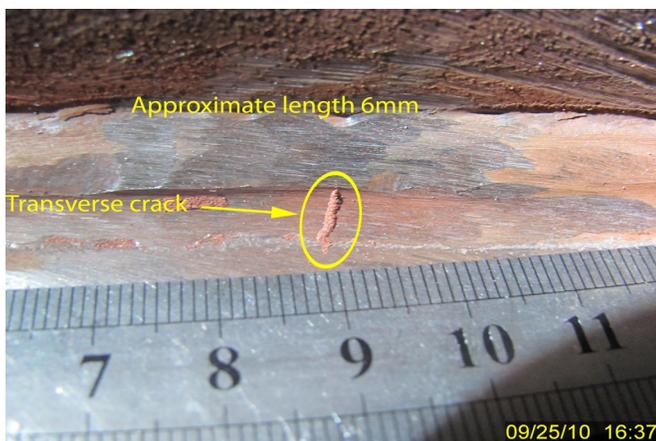
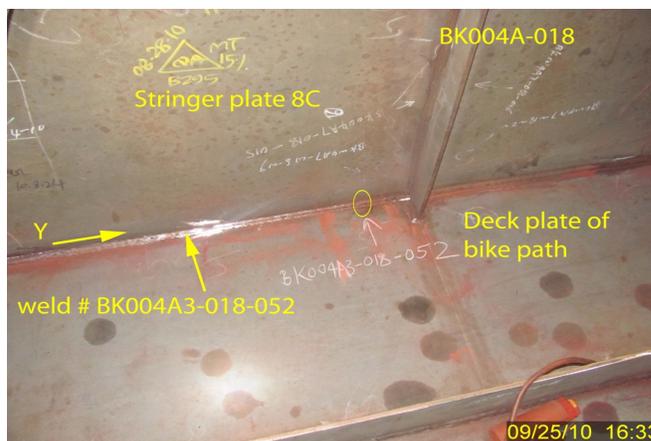
During the Quality Assurance Magnetic Particle Testing (MT) review of fillet welds located on OBG bike path BK004A-018, this Quality Assurance (QA) Inspector discovered the following issues:

-One (1) transverse crack found on the weld measuring approximately 6mm in length.

- Y location of the indication is measured to be 2160mm from one side.
- The indication is clearly marked on the weld joint.
- The weld is identified as: BK004A3-018-052.
- The Weld is a fillet weld joining the stringer plate (8C) to the deck plate of bike path.
- The member is located in bay 11.

The Notice of Witness Inspection Number (NWIT) is 06769. The indication is located within the area that has been previously tested and accepted by ZPMC Quality Control (QC) personnel. The attached photographs provide additional detail. This issue has an incident report.
