DEPARTMENT OF TRANSPORTATION

Contract #: 04-0120F4Cty: SF/ALA Rte: 80 PM: 13.2/13.9File #: 99.28**WELDING INSPECTION REPORT****Resident Engineer:** Siegenthaler, Peter**Address:** 333 Burma Road**City:** Oakland, CA 94607**Report No:** WIR-017180**Date Inspected:** 21-Sep-2010**Project Name:** SAS Superstructure**OSM Arrival Time:** 700**Prime Contractor:** American Bridge/Fluor Enterprises, a JV**OSM Departure Time:** 1900**Contractor:** Zhenhua Port Machinery Company, Ltd (ZPMC) Chanxing Island**Location:** Shanghai, China

WELDING INSPECTION REPORT

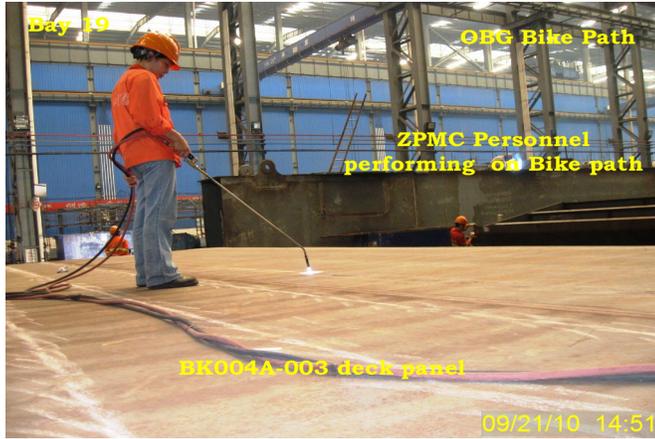
This QA observed ZPMC personnel performing flame straightening by oxygen acetylene on OBG Bike Path BK004A-003 deck panel to deck panel CJP weld, which is used as per HSR(1)-5812. The joining deck panels are identified as BKPL1 and BKPL2. The joint number is identified as BK004A-003-009. See the attached pictures.
