**DEPARTMENT OF TRANSPORTATION**

Contract #: 04-0120F4Cty: SF/ALA Rte: 80 PM: 13.2/13.9File #: 69.28**WELDING INSPECTION REPORT****Resident Engineer:** Siegenthaler, Peter**Address:** 333 Burma Road**City:** Oakland, CA 94607**Report No:** WIR-017193**Date Inspected:** 15-Sep-2010**Project Name:** SAS Superstructure**OSM Arrival Time:** 700**Prime Contractor:** American Bridge/Fluor Enterprises, a JV**OSM Departure Time:** 1900**Contractor:** Zhenhua Port Machinery Company, Ltd (ZPMC), Changxing Island **Location:** Shanghai, China**CWI Name:** Mr. Xu le feng/Qiu wen**CWI Present:** Yes No**Inspected CWI report:** Yes No N/A**Rod Oven in Use:** Yes No N/A**Electrode to specification:** Yes No N/A**Weld Procedures Followed:** Yes No N/A**Qualified Welders:** Yes No N/A**Verified Joint Fit-up:** Yes No N/A**Approved Drawings:** Yes No N/A**Approved WPS:** Yes No N/A**Delayed / Cancelled:** Yes No N/A**Bridge No:** 34-0006**Component:** Tower**Summary of Items Observed:**

## WELDING INSPECTION REPORT

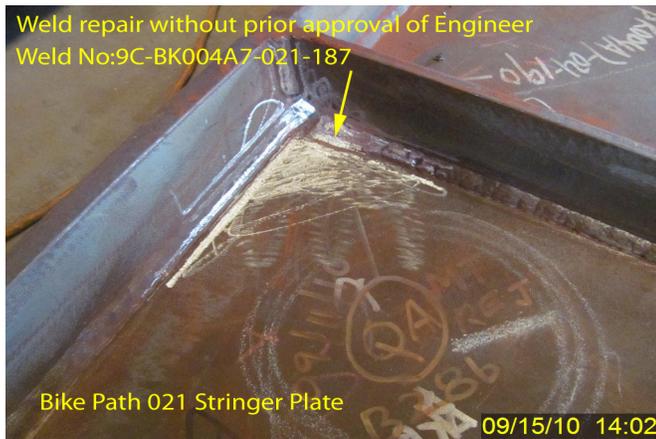
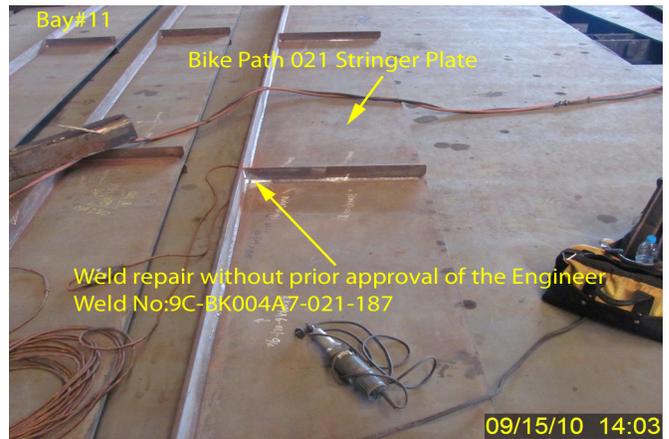
During the Quality Assurance (QA) random in-process observation of the fabrication of Bike Path 021, this QA inspector discovered the following issue:

-ZPMC personnel have performed weld repair one longitudinal crack indication without prior approval of the Engineer.

-The weld is identified as 9C-BK004A7-021-187.

- The weld is a fillet T-joint, joining stiffener identified as BKX7L to stringer plate identified as BKX9C.

-The crack indication is previously discovered and rejected during Magnetic Particle Testing (MT) performed by

this QA inspector.

- The Bike Path 021 Stringer Plate is located in Bay# 11.
- The Notice of Witness Inspection Number (NWIT) is 006673 dated 9/15/10.

This Quality Assurance (QA) Inspector wrote an Incident Report for weld repair without engineer approval. Please reference the Incident Report # 04-0120F4\_TL-15\_B286\_09-15-10\_BK021 weld repair without engineer approval. For further information, please see the attached pictures.
