DEPARTMENT OF TRANSPORTATION

Contract #: 04-0120F4Cty: SF/ALA Rte: 80 PM: 13.2/13.9File #: 69.28**WELDING INSPECTION REPORT****Resident Engineer:** Siegenthaler, Peter**Address:** 333 Burma Road**City:** Oakland, CA 94607**Report No:** WIR-017194**Date Inspected:** 11-Sep-2010**Project Name:** SAS Superstructure**OSM Arrival Time:** 700**Prime Contractor:** American Bridge/Fluor Enterprises, a JV**OSM Departure Time:** 1900**Contractor:** Zhenhua Port Machinery Company, Ltd (ZPMC), Changxing Island **Location:** Shanghai, China**CWI Name:** Mr. Qiu wen**CWI Present:** Yes No**Inspected CWI report:** Yes No N/A**Rod Oven in Use:** Yes No N/A**Electrode to specification:** Yes No N/A**Weld Procedures Followed:** Yes No N/A**Qualified Welders:** Yes No N/A**Verified Joint Fit-up:** Yes No N/A**Approved Drawings:** Yes No N/A**Approved WPS:** Yes No N/A**Delayed / Cancelled:** Yes No N/A**Bridge No:** 34-0006**Component:** Tower**Summary of Items Observed:**

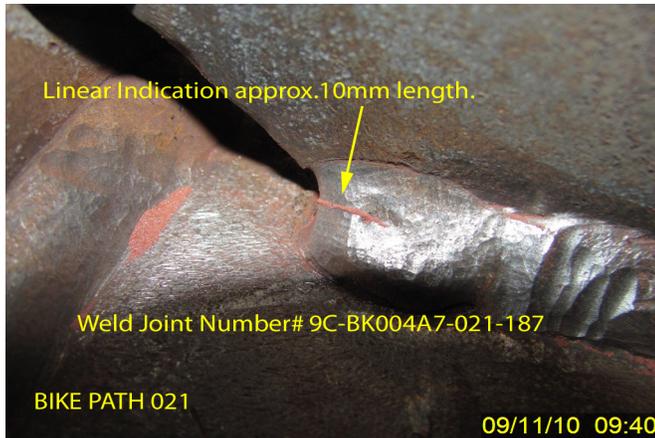
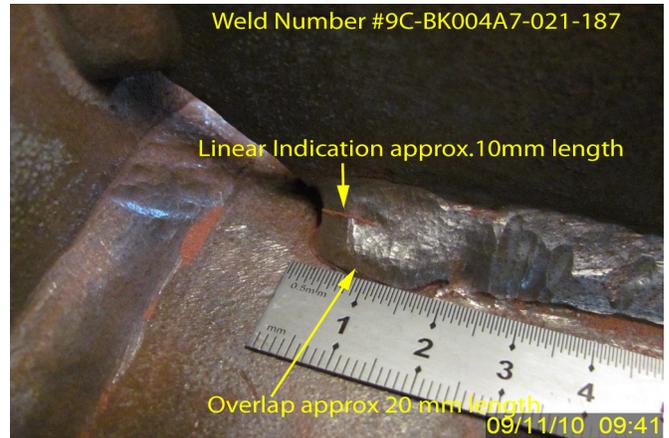
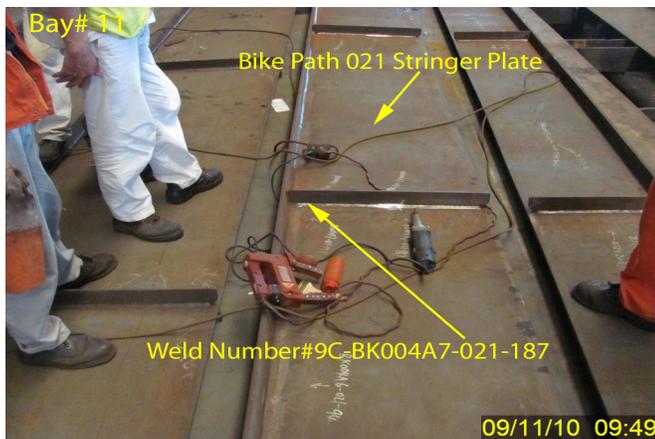
During the Quality Assurance Magnetic Particle Testing (MT) review of welds located on Bike Path 021 this Quality Assurance Inspector (QA) discovered the following issues:

- One linear crack indication in the weld measuring approximately 10mm in length.
- One area of overlap of the fillet weld measuring approximately 20mm in length.
- The weld is identified as 9C-BK004A7-021-187.
- The weld is a fillet T-joint, joining stiffener identified as BKX7L to stringer plate identified as BKX9C.
- The indications are clearly marked on the material near the weld.
- The Bike Path 021 Stringer Plate is located in Bay# 11.

The Notice of Witness Inspection Number (NWIT) is 006640. The indication is located within an area previously tested and accepted by ZPMC Quality Control (QC) personnel.
