**DEPARTMENT OF TRANSPORTATION**

Contract #: 04-0120F4Cty: SF/ALA Rte: 80 PM: 13.2/13.9File #: 1.28**WELDING INSPECTION REPORT****Resident Engineer:** Siegenthaler, Peter**Address:** 333 Burma Road**City:** Oakland, CA 94607**Report No:** WIR-017245**Date Inspected:** 05-Oct-2010**Project Name:** SAS Superstructure**OSM Arrival Time:** 1000**Prime Contractor:** American Bridge/Fluor Enterprises, a JV**OSM Departure Time:** 1830**Contractor:** American Bridge/Fluor Enterprises, a JV**Location:** Job Site

<b>CWI Name:</b>	Patrick Swain and Tom Pasqualone			<b>CWI Present:</b>	Yes	No	
<b>Inspected CWI report:</b>	Yes	No	N/A	<b>Rod Oven in Use:</b>	Yes	No	N/A
<b>Electrode to specification:</b>	Yes	No	N/A	<b>Weld Procedures Followed:</b>	Yes	No	N/A
<b>Qualified Welders:</b>	Yes	No	N/A	<b>Verified Joint Fit-up:</b>	Yes	No	N/A
<b>Approved Drawings:</b>	Yes	No	N/A	<b>Approved WPS:</b>	Yes	No	N/A
				<b>Delayed / Cancelled:</b>	Yes	No	N/A
<b>Bridge No:</b>	34-0006			<b>Component:</b>	Orthotropic Box Girder

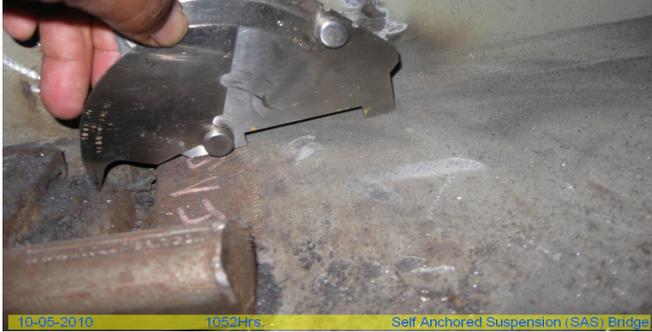
10-05-2010 1600Hrs Self Anchored Suspension (SAS) Bridge

At OBG 6W/7W side plate 'E' inside, QC noted a misalignment of 1mm to 5mm from corner (Start) to 150mm length of the splice. Per ABF QC Bonifacio Daquinag, QC has already submitted their measurements to ABF for review and approval.

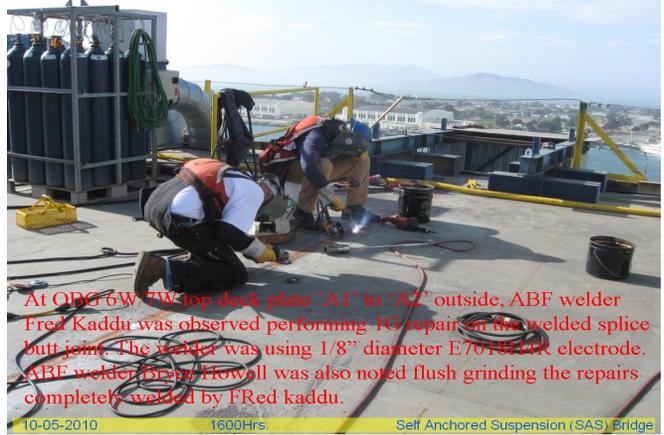
10-05-2010 1600Hrs Self Anchored Suspension (SAS) Bridge

At OBG 6W/7W top deck plate 'A1' to 'A2' outside, ABF welder Fred Kaddu was observed performing IG repair on the welded splice butt joint. The welder was using 1/8" diameter E7018LR electrode. ABF welder Brian Howell was also noted flush grinding the repairs completely welded by Fred kaddu.

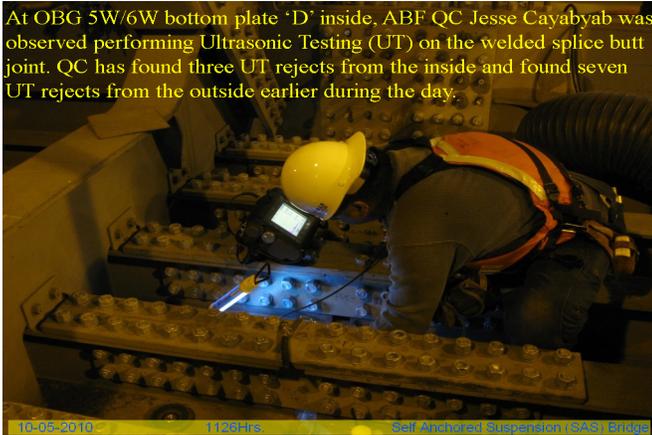
10-05-2010 1600Hrs Self Anchored Suspension (SAS) Bridge

At OBG 5W/6W bottom plate 'D' inside, ABF QC Jesse Cayabyab was observed performing Ultrasonic Testing (UT) on the welded splice butt joint. QC has found three UT rejects from the inside and found seven UT rejects from the outside earlier during the day.
