DEPARTMENT OF TRANSPORTATION

Contract #: 04-0120F4Cty: SF/ALA Rte: 80 PM: 13.2/13.9File #: 1.28**WELDING INSPECTION REPORT****Resident Engineer:** Siegenthaler, Peter**Address:** 333 Burma Road**City:** Oakland, CA 94607**Report No:** WIR-017353**Date Inspected:** 13-Oct-2010**Project Name:** SAS Superstructure**OSM Arrival Time:** 1000**Prime Contractor:** American Bridge/Fluor Enterprises, a JV**OSM Departure Time:** 1830**Contractor:** American Bridge/Fluor Enterprises, a JV**Location:** Job Site**CWI Name:** See Below**CWI Present:** Yes No**Inspected CWI report:** Yes No N/A**Rod Oven in Use:** Yes No N/A**Electrode to specification:** Yes No N/A**Weld Procedures Followed:** Yes No N/A**Qualified Welders:** Yes No N/A**Verified Joint Fit-up:** Yes No N/A**Approved Drawings:** Yes No N/A**Approved WPS:** Yes No N/A**Delayed / Cancelled:** Yes No N/A**Bridge No:** 34-0006**Component:** Orthotropic Box Girders**Summary of Items Observed:**

WELDING INSPECTION REPORT

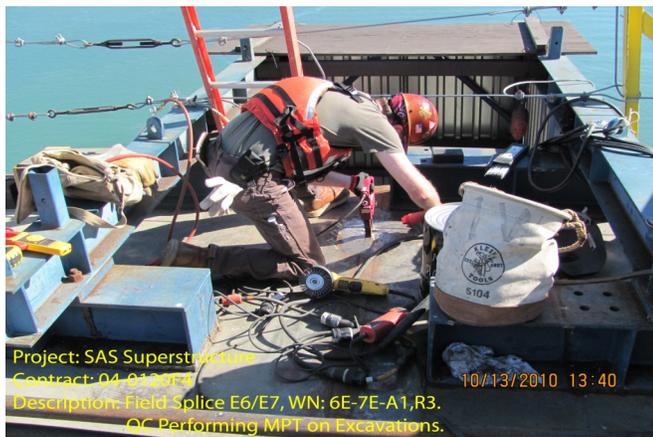
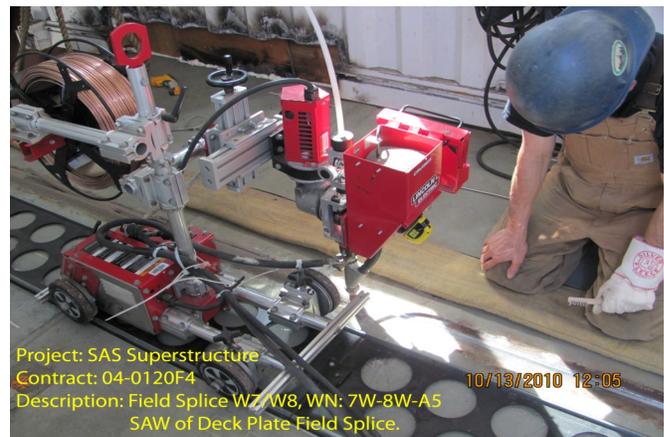
The digital photographs below illustrate the work observed during this scheduled shift.
