DEPARTMENT OF TRANSPORTATION

Quality Assurance and Source Inspection

Contract #: 04-0120F4Cty: SF/ALA Rte: 80 PM: 13.2/13.9File #: 1.28**WELDING INSPECTION REPORT****Resident Engineer:** Siegenthaler, Peter**Address:** 333 Burma Road**City:** Oakland, CA 94607**Report No:** WIR-017357**Date Inspected:** 06-Oct-2010**Project Name:** SAS Superstructure**OSM Arrival Time:** 630**Prime Contractor:** American Bridge/Fluor Enterprises, a JV**OSM Departure Time:** 1500**Contractor:** American Bridge/Fluor Enterprises, a JV**Location:** Job Site**CWI Name:** See below**CWI Present:** Yes No**Inspected CWI report:** Yes No N/A**Rod Oven in Use:** Yes No N/A**Electrode to specification:** Yes No N/A**Weld Procedures Followed:** Yes No N/A**Qualified Welders:** Yes No N/A**Verified Joint Fit-up:** Yes No N/A**Approved Drawings:** Yes No N/A**Approved WPS:** Yes No N/A**Delayed / Cancelled:** Yes No N/A**Bridge No:** 34-0006**Component:** SAS OBG**Summary of Items Observed:**

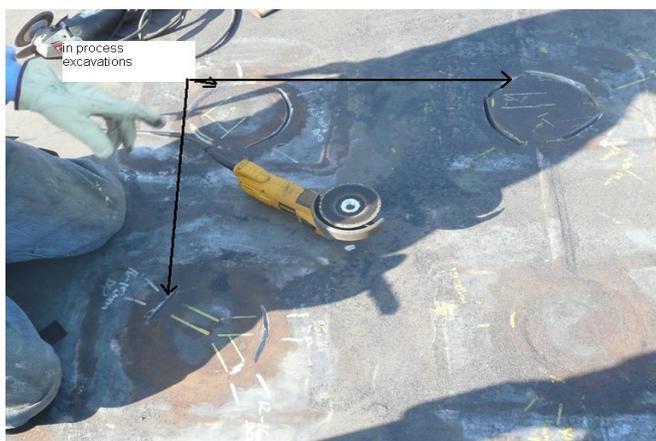
1E-pp11-E4-1, 2, 3, 4

The QA Inspector randomly observed the ABF welder identified as Darcel Jackson utilizing a grinding disc and a burr bit grinder to excavate previously located and indicated ultrasonic testing rejections. The QA Inspector noted the hole identified as #1 had a total of 5 UT rejects, hole identified as #2 had a total of 2 UT rejects, hole identified as #3 had a total of 3 UT rejects and hole # 5 had a total of 4 UT rejects. The QA Inspector noted no welding was performed on the QA Inspectors shift, only excavations. The ABF welder Darcel Jackson informed the QA Inspector, no other ABF welders will be performing welding of the lifting lug hole restorations. Mr. Jackson informed the QA Inspector he was informed by the ABF Welding Superintendent Dan Ieraci the other welder that previously performed welding on the lifting lug hole had too high of a reject rate.
