DEPARTMENT OF TRANSPORTATION

Contract #: 04-0120F4Cty: SF/ALA Rte: 80 PM: 13.2/13.9File #: 1.28**WELDING INSPECTION REPORT****Resident Engineer:** Siegenthaler, Peter**Address:** 333 Burma Road**City:** Oakland, CA 94607**Report No:** WIR-017358**Date Inspected:** 05-Oct-2010**Project Name:** SAS Superstructure**OSM Arrival Time:** 700**Prime Contractor:** American Bridge/Fluor Enterprises, a JV**OSM Departure Time:** 1530**Contractor:** American Bridge/Fluor Enterprises, a JV**Location:** Jobsite**CWI Name:** See below**CWI Present:** Yes No**Inspected CWI report:** Yes No N/A**Rod Oven in Use:** Yes No N/A**Electrode to specification:** Yes No N/A**Weld Procedures Followed:** Yes No N/A**Qualified Welders:** Yes No N/A**Verified Joint Fit-up:** Yes No N/A**Approved Drawings:** Yes No N/A**Approved WPS:** Yes No N/A**Delayed / Cancelled:** Yes No N/A**Bridge No:** 34-0006**Component:** SAS OBG**Summary of Items Observed:**

WELDING INSPECTION REPORT

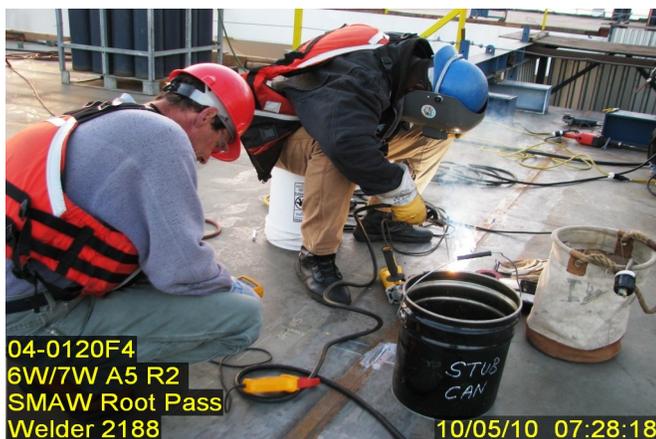
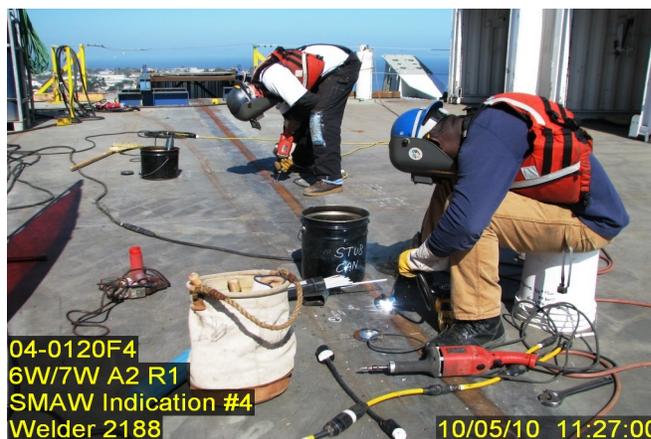
The QAI periodically observed AB/F approved welder Bryce Howell (ID 5591) performing grinding from face A to excavate QC Ultrasonic Testing (UT) R-1 and R-2 repair areas at OBG Field Splice 6W/7W weld ID: A2, A4 and A5. Mr. Howell excavated three (4) R-1 repair areas in weld A2 labeled on the steel as indications (1), (2), (3) & (4), with the following locations and dimensions: indication 1) - Length = 90mm, depth = 12mm and Y = 705mm, indication 2) - Length = 90mm, depth = 13mm and Y = 2560mm, indication 3) - Length = 90mm, depth = 14mm and Y = 4335mm & indication 4) - Length = 90mm, depth = 14mm and Y = 5165mm. Mr. Howell also excavated one (1) R-1 repair areas in at the junction of welds A4 and A5 with the following location and dimensions: Length = 100mm, depth = 14mm and A4- Y = 5450mm. Mr. Howell also excavated three (3) R-2 repair areas in weld A5 with the following locations and dimensions: 1st indication - Length = unknown, depth = 13mm and Y = 690mm, 2nd indication Length = 90mm, depth = 14mm and Y = 1420mm & 3rd indication Length = 160mm, depth = 20mm and Y = 4310mm. The QAI periodically observed AB/F approved welder Fred Kaddu performing repair welding of excavated areas per the SMAW process in the 1G (flat) position at all Y locations described above. The QAI periodically observed QC Inspectors Tom Pasqualone and Steve McConnell performing Magnetic Particle Testing (MT) of excavated UT repair areas prior to welding. The QAI observed that

the performance and evaluation of the MT appeared to comply with the MT procedure identified as SE-MT-CT-D1.5-101 Rev. 4. The QAI periodically observed QC Inspector Tom Pasqualone was present to monitor the progress and verify that the welding parameters were within the limits established by the approved welding Procedure Specification (WPS) identified as ABF-WPS-D1.5-1000-Repair. See photos below. Repair welding was in process at this location and the work at this location appeared to be in general compliance with contract documents.
