**DEPARTMENT OF TRANSPORTATION**

Contract #: 04-0120F4Cty: SF/ALA Rte: 80 PM: 13.2/13.9File #: 1.28**WELDING INSPECTION REPORT****Resident Engineer:** Siegenthaler, Peter**Address:** 333 Burma Road**City:** Oakland, CA 94607**Report No:** WIR-017359**Date Inspected:** 08-Oct-2010**Project Name:** SAS Superstructure**OSM Arrival Time:** 700**Prime Contractor:** American Bridge/Fluor Enterprises, a JV**OSM Departure Time:** 1530**Contractor:** American Bridge/Fluor Enterprises, a JV**Location:** Jobsite**CWI Name:** See below**CWI Present:** Yes No**Inspected CWI report:** Yes No N/A**Rod Oven in Use:** Yes No N/A**Electrode to specification:** Yes No N/A**Weld Procedures Followed:** Yes No N/A**Qualified Welders:** Yes No N/A**Verified Joint Fit-up:** Yes No N/A**Approved Drawings:** Yes No N/A**Approved WPS:** Yes No N/A**Delayed / Cancelled:** Yes No N/A**Bridge No:** 34-0006**Component:** SAS OBG**Summary of Items Observed:**

## WELDING INSPECTION REPORT

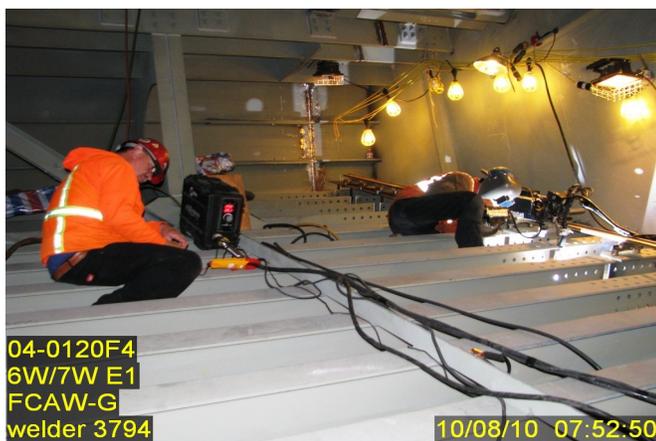
The QAI periodically observed AB/F approved welder Song Tao Huang (ID 3794) performing welding per the Flux Cored Arc Welding (FCAW-G) process in the 3G (vertical) position of fill and cover passes on weld ID: E1. The QAI observed QC Inspector John Pagliero was present to monitor the progress and verify that the welding parameters were within the limits established by the approved Welding Procedure Specification (WPS) identified

as ABF-WPS-D1.5-3042B-1. See photo below. The QAI observed that the work at this location was in process for the duration of the shift and appeared to be in general compliance with contract documents.
