**DEPARTMENT OF TRANSPORTATION**

Contract #: 04-0120F4Cty: SF/ALA Rte: 80 PM: 13.2/13.9File #: 1.28**WELDING INSPECTION REPORT****Resident Engineer:** Siegenthaler, Peter**Address:** 333 Burma Road**City:** Oakland, CA 94607**Report No:** WIR-017360**Date Inspected:** 07-Oct-2010**Project Name:** SAS Superstructure**OSM Arrival Time:** 630**Prime Contractor:** American Bridge/Fluor Enterprises, a JV**OSM Departure Time:** 1500**Contractor:** American Bridge/Fluor Enterprises, a JV**Location:** Job Site**CWI Name:** See below**CWI Present:** Yes No**Inspected CWI report:** Yes No N/A**Rod Oven in Use:** Yes No N/A**Electrode to specification:** Yes No N/A**Weld Procedures Followed:** Yes No N/A**Qualified Welders:** Yes No N/A**Verified Joint Fit-up:** Yes No N/A**Approved Drawings:** Yes No N/A**Approved WPS:** Yes No N/A**Delayed / Cancelled:** Yes No N/A**Bridge No:** 34-0006**Component:** SAS OBG**Summary of Items Observed:**

# WELDING INSPECTION REPORT

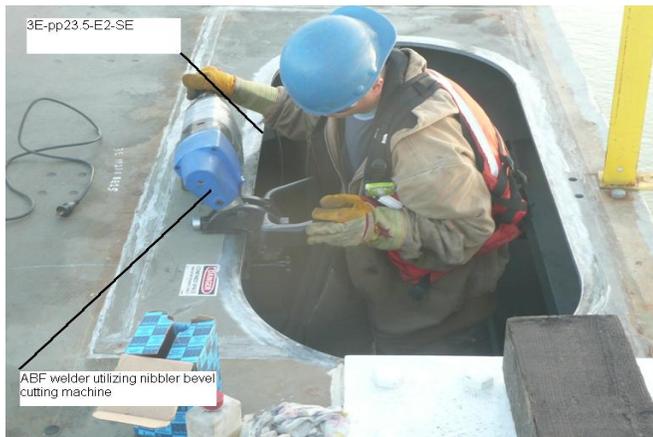
1E-pp11-E4-1, 3, 4

The QA Inspector randomly observed Darcel Jackson performing grinding tasks of ultrasonic testing rejects in the above identified lifting lug deck hole restoration. The QA Inspector randomly observed the ABF welder had previously excavated all four of the UT rejections located in the above identified hole. The QA Inspector randomly observed the ABF welder had not completed any of the SMAW repairs upon the arrival of the QA inspector in the am. The QA Inspector randomly observed the Smith Emery (SE) Quality Control (QC) Inspector Patrick Swain was on site to monitor and record the in process welding parameters. The QA Inspector noted the ABF welder was utilizing the shielded metal arc welding process with 1/8" E7018 low hydrogen electrodes. The QA Inspector randomly observed the ABF welder was utilizing 135 Amps while performing the SMAW repair. The QA Inspector performed a random visual inspection of the previously excavated areas and noted they had been ground and blended to a boat shaped weldable profile. The QA Inspector randomly observed and noted the ABF welder was preheating the material to approximately 100°F prior to making the SMAW repairs. The QA Inspector noted the SMAW repairs appeared to be in general compliance with ABF-WPS-1001 repair. The QA Inspector noted the repair welding was not completed on the QA Inspectors shift.
