DEPARTMENT OF TRANSPORTATION

Contract #: 04-0120F4Cty: SF/ALA Rte: 80 PM: 13.2/13.9File #: 1.28**WELDING INSPECTION REPORT****Resident Engineer:** Siegenthaler, Peter**Address:** 333 Burma Road**City:** Oakland, CA 94607**Report No:** WIR-017362**Date Inspected:** 07-Oct-2010**Project Name:** SAS Superstructure**OSM Arrival Time:** 1000**Prime Contractor:** American Bridge/Fluor Enterprises, a JV**OSM Departure Time:** 1830**Contractor:** American Bridge/Fluor Enterprises, a JV**Location:** Job Site

CWI Name:	Bonifacio Daquinag and Jesse Cayabyab			CWI Present:	Yes	No	
Inspected CWI report:	Yes	No	N/A	Rod Oven in Use:	Yes	No	N/A
Electrode to specification:	Yes	No	N/A	Weld Procedures Followed:	Yes	No	N/A
Qualified Welders:	Yes	No	N/A	Verified Joint Fit-up:	Yes	No	N/A
Approved Drawings:	Yes	No	N/A	Approved WPS:	Yes	No	N/A
				Delayed / Cancelled:	Yes	No	N/A
Bridge No:	34-0006			Component:	Orthotropic Box Girder

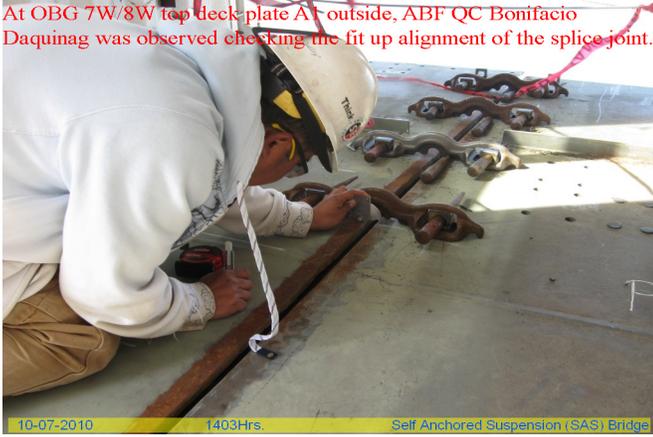
10-07-2010 1403Hrs. Self Anchored Suspension (SAS) Bridge

At OBG 7W/8W top deck plate A' outside, ABF QC Bonifacio Daquinag was observed checking the fit up alignment of the splice joint.

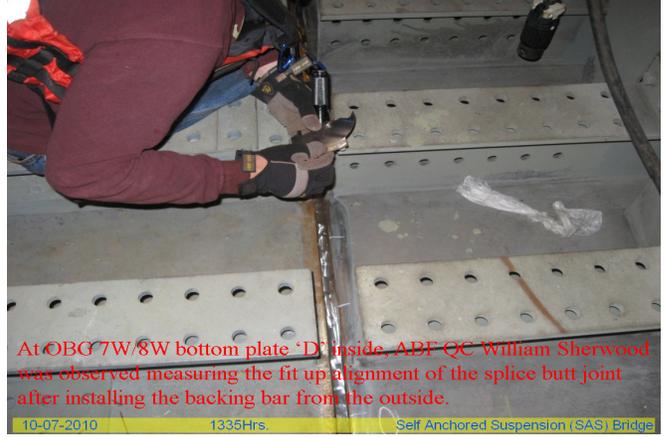
10-07-2010 1335Hrs. Self Anchored Suspension (SAS) Bridge

At OBG 7W/8W bottom plate 'D' inside, ABF QC William Sherwood was observed measuring the fit up alignment of the splice butt joint after installing the backing bar from the outside.
