**DEPARTMENT OF TRANSPORTATION**

Contract #: 04-0120F4Cty: SF/ALA Rte: 80 PM: 13.2/13.9File #: 1.28**WELDING INSPECTION REPORT****Resident Engineer:** Siegenthaler, Peter**Address:** 333 Burma Road**City:** Oakland, CA 94607**Report No:** WIR-017428**Date Inspected:** 12-Oct-2010**Project Name:** SAS Superstructure**OSM Arrival Time:** 1000**Prime Contractor:** American Bridge/Fluor Enterprises, a JV**OSM Departure Time:** 1830**Contractor:** American Bridge/Fluor Enterprises, a JV**Location:** Job Site

# WELDING INSPECTION REPORT

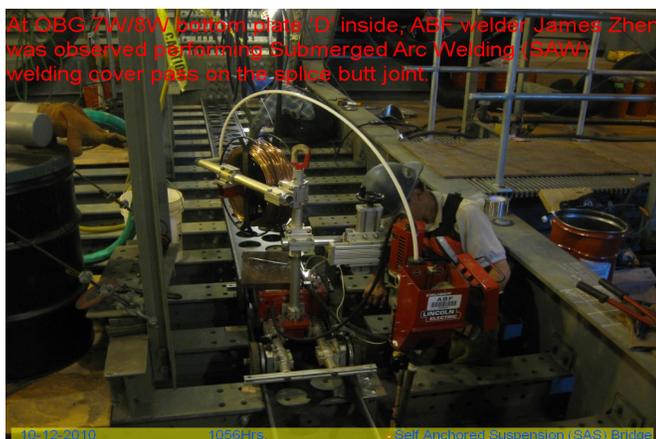
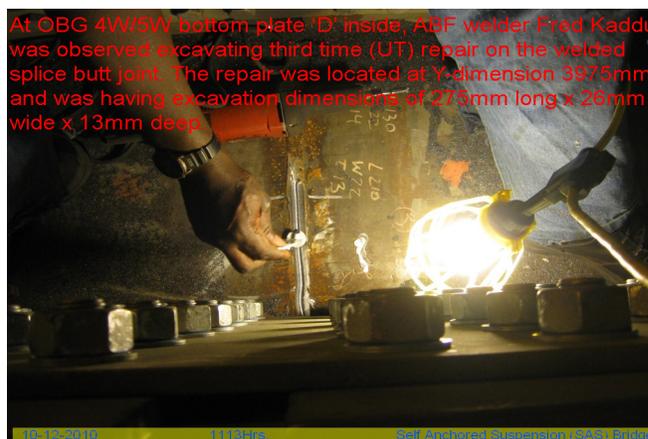
At OBG 4W/5W bottom plate 'D' inside, QA randomly observed ABF/JV qualified welder Fred Kaddu ID # 2188 perform CJP groove welding repair. The welder was observed welding in the 1G (flat) position utilizing Shielded Metal Arc Welding (SMAW) with 1/8" diameter E7018H4R electrode implementing welding procedure ABF-WPS-D15-1000-Repairs. The repair was located at Y dimension 3975mm and was having a repair excavation dimension of 275mm long x 26mm wide x 13mm deep. The repair excavation was preheated to more than 140 degree Fahrenheit using propane gas torch prior welding. During the shift, ABF QC Jesse Cayabyab was noted monitoring the welder. Prior welding, ABF QC Jesse Cayabyab was also observed performing Magnetic Particle Testing (MT) using Parker Contour Probe with red magnetic powder as detecting media on the repair excavation. There were no significant defects noted during the test. Before the end of the shift, welding repair at this location was completed and visually accepted by ABF QC.
