DEPARTMENT OF TRANSPORTATION

Contract #: 04-0120F4Cty: SF/ALA Rte: 80 PM: 13.2/13.9File #: 69.28**WELDING INSPECTION REPORT****Resident Engineer:** Siegenthaler, Peter**Address:** 333 Burma Road**City:** Oakland, CA 94607**Report No:** WIR-017431**Date Inspected:** 24-Sep-2010**Project Name:** SAS Superstructure**OSM Arrival Time:** 700**Prime Contractor:** American Bridge/Fluor Enterprises, a JV**OSM Departure Time:** 1900**Contractor:** Zhenhua Port Machinery Company, Ltd (ZPMC), Changxing Island **Location:** Shanghai, China**CWI Name:** Qiu Wen**CWI Present:** Yes No**Inspected CWI report:** Yes No N/A**Rod Oven in Use:** Yes No N/A**Electrode to specification:** Yes No N/A**Weld Procedures Followed:** Yes No N/A**Qualified Welders:** Yes No N/A**Verified Joint Fit-up:** Yes No N/A**Approved Drawings:** Yes No N/A**Approved WPS:** Yes No N/A**Delayed / Cancelled:** Yes No N/A**Bridge No:** 34-0006**Component:** Tower & OBG Components**Summary of Items Observed:**

BAY#10**ORTHOTROPIC BOX GIRDER (OBG) AT BAY#10**

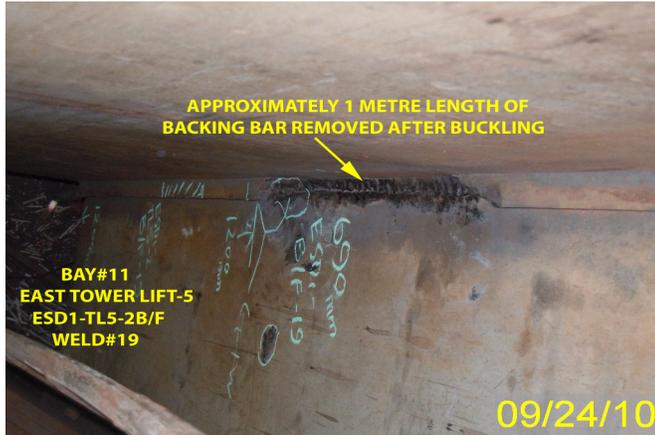
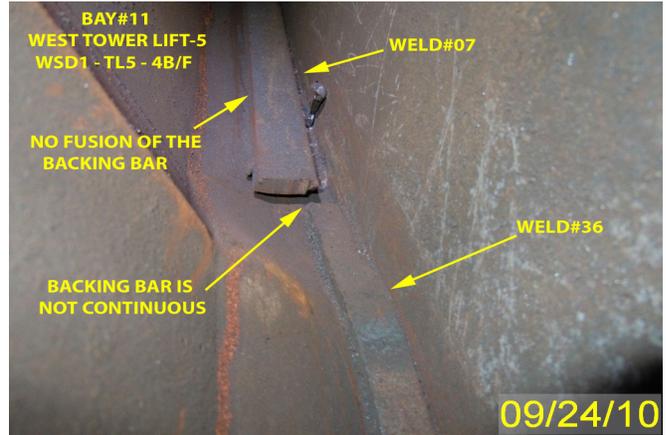
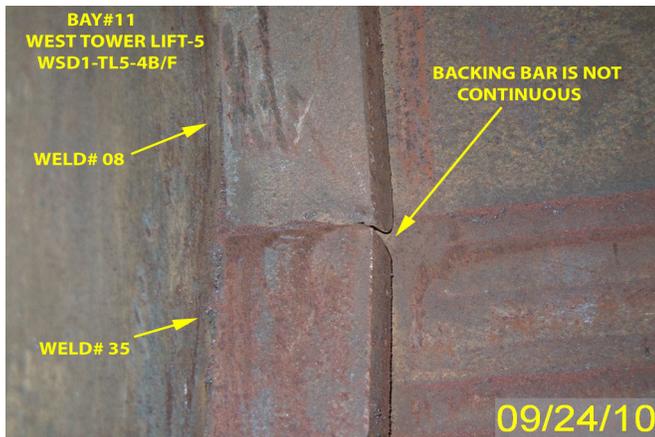
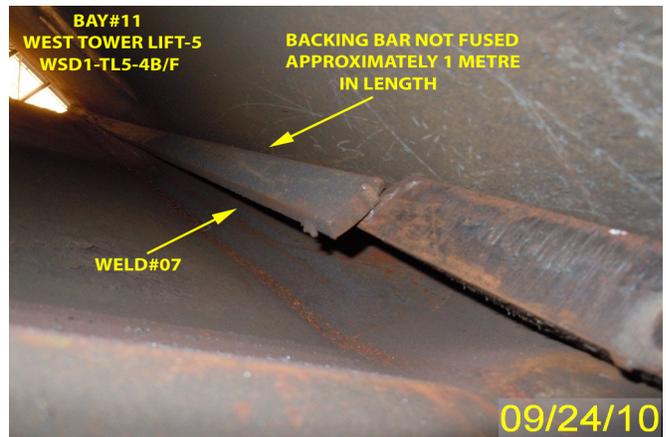
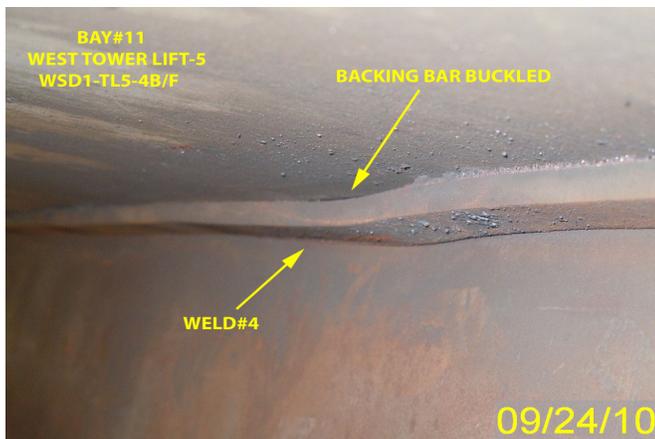
BACKING BAR SURVEY ON LIFT-5 TOWER SHAFTS AT BAY#10 & 11

During survey the following discrepancies found on lift-5 tower shafts: -

EAST TOWER LIFT-5:

1. Approximately 1 metre length of backing bar removed after buckling (ESD1-TL5-2B-F#19)

WEST TOWER LIFT-5:

1. Backing bar buckled (WSD1-TL5-4B-F#04)
2. Backing bar not fused approximately 1 metre in length (WSD1-TL5-4B-F#07) and not continuous between the

welds (WSD1-TL5-4B-F#07&36)

3. Backing bar is not continuous between the welds (WSD1-TL5-4B-F#08&35)
