DEPARTMENT OF TRANSPORTATION

Quality Assurance and Source Inspection

Contract #: 04-0120F4Cty: SF/ALA Rte: 80 PM: 13.2/13.9File #: 69.28**WELDING INSPECTION REPORT****Resident Engineer:** Siegenthaler, Peter**Address:** 333 Burma Road**City:** Oakland, CA 94607**Report No:** WIR-017435**Date Inspected:** 29-Sep-2010**Project Name:** SAS Superstructure**OSM Arrival Time:** 700**Prime Contractor:** American Bridge/Fluor Enterprises, a JV**OSM Departure Time:** 1900**Contractor:** Zhenhua Port Machinery Company, Ltd (ZPMC), Changxing Island **Location:** Shanghai, China**CWI Name:** Xu Le Feng**CWI Present:** Yes No**Inspected CWI report:** Yes No N/A**Rod Oven in Use:** Yes No N/A**Electrode to specification:** Yes No N/A**Weld Procedures Followed:** Yes No N/A**Qualified Welders:** Yes No N/A**Verified Joint Fit-up:** Yes No N/A**Approved Drawings:** Yes No N/A**Approved WPS:** Yes No N/A**Delayed / Cancelled:** Yes No N/A**Bridge No:** 34-0006**Component:** Tower & OBG Components**Summary of Items Observed:**

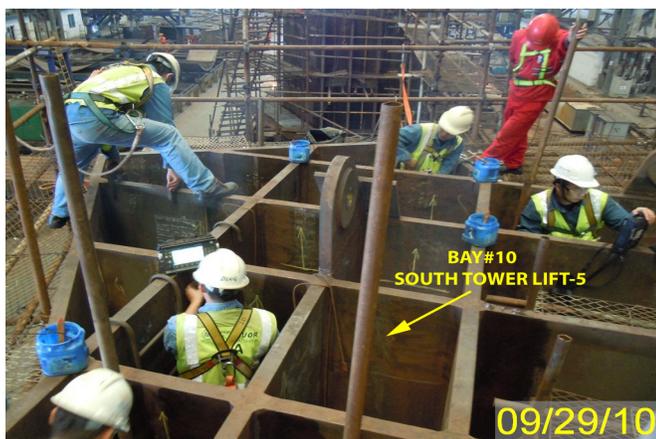
This QA inspector Witnessed UT performed by ABF personnel as per the tensile stress criteria (table 6.3). The member is identified as TOWER Component. The component identified as follows:

SOUTH AND NORTH TOWER LIFT-5 GRILLAGE WELDS

(See attached photo)

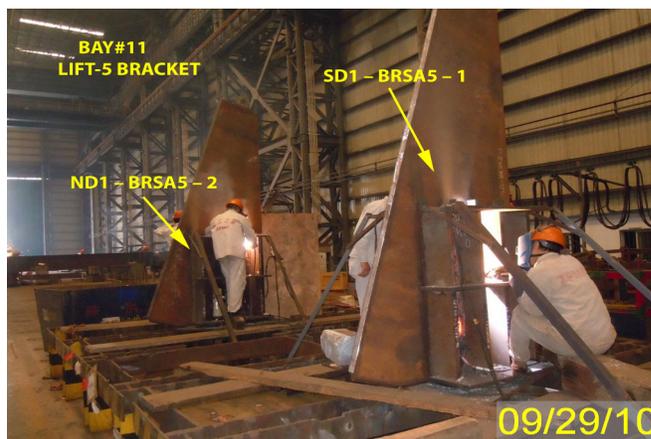
Weld joint # 09A located on Lift-5 Bracket SD1 – BRSA5 – 1. Welder is identified as 041271. ZPMC Quality Control (QC) Inspector is identified as Yu Dong Ping. The welding variables recorded by QC appeared to comply with the WPS – B – T – 3213 – Tc – U4b. (See attached photo)
