DEPARTMENT OF TRANSPORTATION

Contract #: 04-0120F4Cty: SF/ALA Rte: 80 PM: 13.2/13.9File #: 1.28**WELDING INSPECTION REPORT****Resident Engineer:** Siegenthaler, Peter**Address:** 333 Burma Road**City:** Oakland, CA 94607**Report No:** WIR-017448**Date Inspected:** 14-Oct-2010**Project Name:** SAS Superstructure**OSM Arrival Time:** 1000**Prime Contractor:** American Bridge/Fluor Enterprises, a JV**OSM Departure Time:** 1830**Contractor:** American Bridge/Fluor Enterprises, a JV**Location:** Job Site**CWI Name:** See Below**CWI Present:** Yes No**Inspected CWI report:** Yes No N/A**Rod Oven in Use:** Yes No N/A**Electrode to specification:** Yes No N/A**Weld Procedures Followed:** Yes No N/A**Qualified Welders:** Yes No N/A**Verified Joint Fit-up:** Yes No N/A**Approved Drawings:** Yes No N/A**Approved WPS:** Yes No N/A**Delayed / Cancelled:** Yes No N/A**Bridge No:** 34-0006**Component:** Orthotropic Box Girders**Summary of Items Observed:**

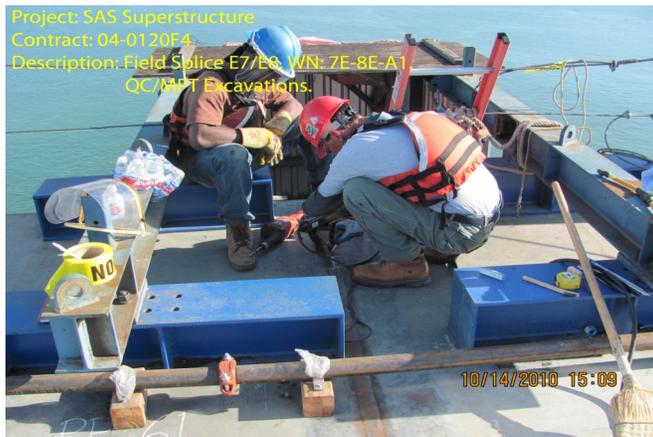
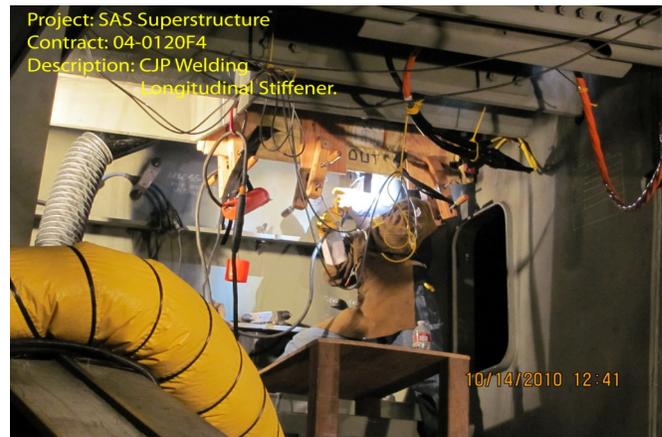
The digital photographs below illustrate the work observed during this scheduled shift.
