DEPARTMENT OF TRANSPORTATION

Office of Structural Materials

Contract #: 04-0120F4Cty: SF/ALA Rte: 80 PM: 13.2/13.9File #: 1.28**WELDING INSPECTION REPORT****Resident Engineer:** Siegenthaler, Peter**Address:** 333 Burma Road**City:** Oakland, CA 94607**Report No:** WIR-017459**Date Inspected:** 15-Oct-2010**Project Name:** SAS Superstructure**OSM Arrival Time:** 900**Prime Contractor:** American Bridge/Fluor Enterprises, a JV**OSM Departure Time:** 1730**Contractor:** American Bridge/Fluor Enterprises, a JV**Location:** Job Site**CWI Name:** See Below**CWI Present:** Yes No**Inspected CWI report:** Yes No N/A**Rod Oven in Use:** Yes No N/A**Electrode to specification:** Yes No N/A**Weld Procedures Followed:** Yes No N/A**Qualified Welders:** Yes No N/A**Verified Joint Fit-up:** Yes No N/A**Approved Drawings:** Yes No N/A**Approved WPS:** Yes No N/A**Delayed / Cancelled:** Yes No N/A**Bridge No:** 34-0006**Component:** Orthotropic Box Girders**Summary of Items Observed:**

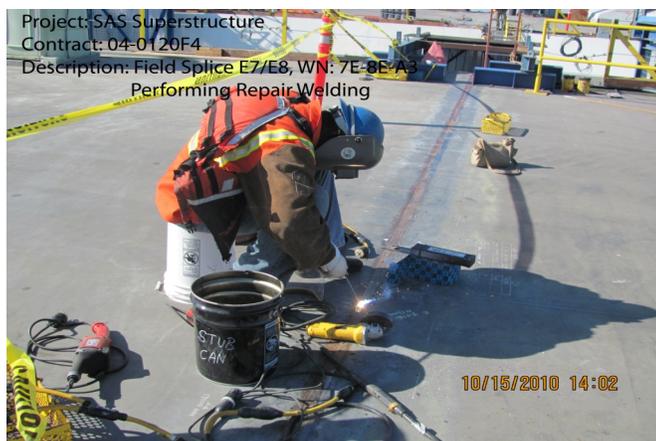
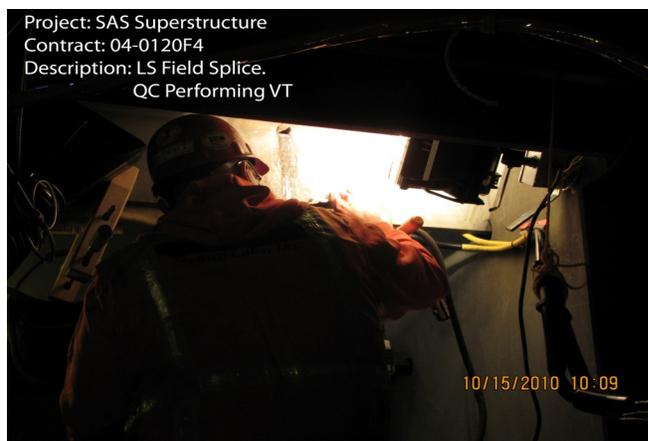
The digital photographs below illustrate the work observed during this scheduled shift.
