Contract #: 04-0120F4Cty: SF/ALA Rte: 80 PM: 13.2/13.9File #: 1.28**WELDING INSPECTION REPORT****Resident Engineer:** Siegenthaler, Peter**Address:** 333 Burma Road**City:** Oakland, CA 94607**Report No:** WIR-017460**Date Inspected:** 15-Oct-2010**Project Name:** SAS Superstructure**OSM Arrival Time:** 730**Prime Contractor:** American Bridge/Fluor Enterprises, a JV**OSM Departure Time:** 1600**Contractor:** American Bridge/Fluor Enterprises, a JV**Location:** Job Site**CWI Name:** Chuck Kanapicki**CWI Present:** Yes No**Inspected CWI report:** Yes No N/A**Rod Oven in Use:** Yes No N/A**Electrode to specification:** Yes No N/A**Weld Procedures Followed:** Yes No N/A**Qualified Welders:** Yes No N/A**Verified Joint Fit-up:** Yes No N/A**Approved Drawings:** Yes No N/A**Approved WPS:** Yes No N/A**Delayed / Cancelled:** Yes No N/A**Bridge No:** 34-0006**Component:** S.A.S. components**Summary of Items Observed:**

WELDING INSPECTION REPORT

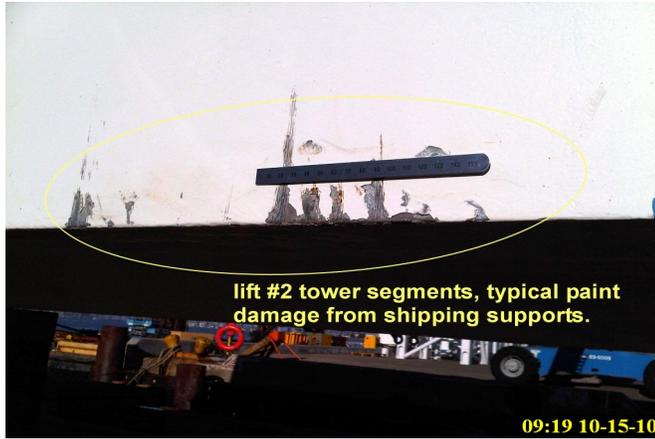
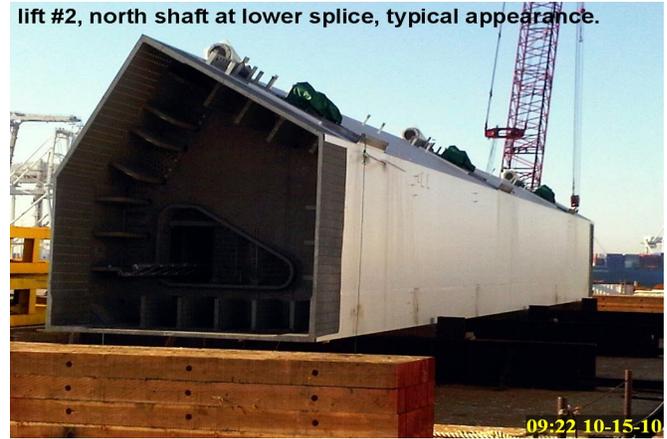
The QAI accompanied the QAI Robert Mertz, the Structural Materials Representative (SMR) Jason Lee and ABF representative Chuck Kanapicki in conducting the post arrival inspection of voyage 5 tower components. During the inspection, the QAI noted that painted surfaces have been marred from general shipping and handling. There was no other shipping related damage observed during this inspection. The QAI noted that parts examined include tower shafts, tower struts and strut facade components. The QAI noted that at this time, all major tower components of Voyage 5 have been examined for post arrival inspection. See the attached photos.
