DEPARTMENT OF TRANSPORTATION

Contract #: 04-0120F4Cty: SF/ALA Rte: 80 PM: 13.2/13.9File #: 1.28**WELDING INSPECTION REPORT****Resident Engineer:** Siegenthaler, Peter**Address:** 333 Burma Road**City:** Oakland, CA 94607**Report No:** WIR-017484**Date Inspected:** 20-Oct-2010**Project Name:** SAS Superstructure**OSM Arrival Time:** 1000**Prime Contractor:** American Bridge/Fluor Enterprises, a JV**OSM Departure Time:** 1830**Contractor:** American Bridge/Fluor Enterprises, a JV**Location:** Job Site**CWI Name:** See Below**CWI Present:** Yes No**Inspected CWI report:** Yes No N/A**Rod Oven in Use:** Yes No N/A**Electrode to specification:** Yes No N/A**Weld Procedures Followed:** Yes No N/A**Qualified Welders:** Yes No N/A**Verified Joint Fit-up:** Yes No N/A**Approved Drawings:** Yes No N/A**Approved WPS:** Yes No N/A**Delayed / Cancelled:** Yes No N/A**Bridge No:** 34-0006**Component:** Orthotropic Box Girders**Summary of Items Observed:**

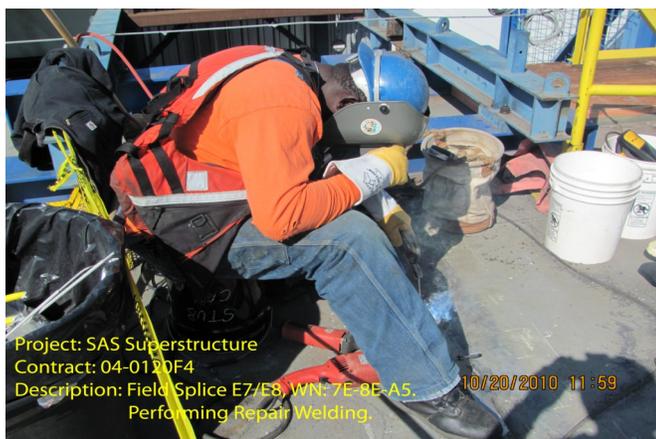
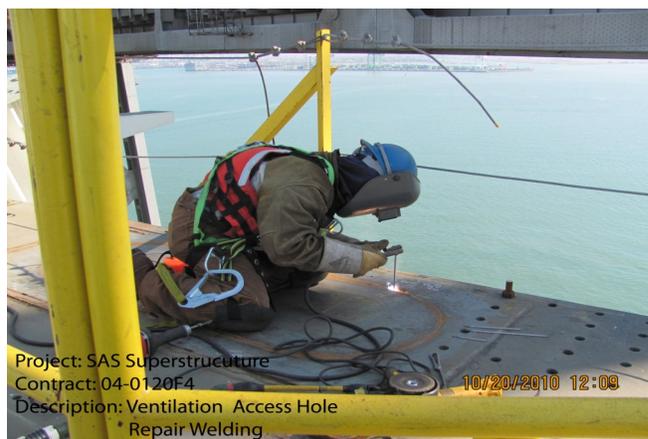
The digital photographs below illustrate the work observed during this scheduled shift.
