DEPARTMENT OF TRANSPORTATION

Quality Assurance and Source Inspection

WELDING INSPECTION REPORT

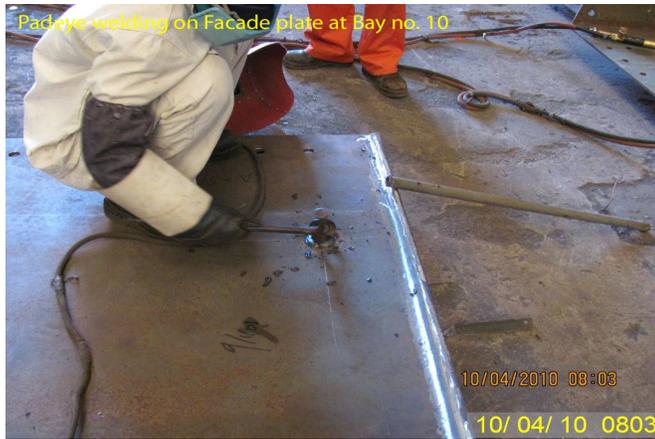
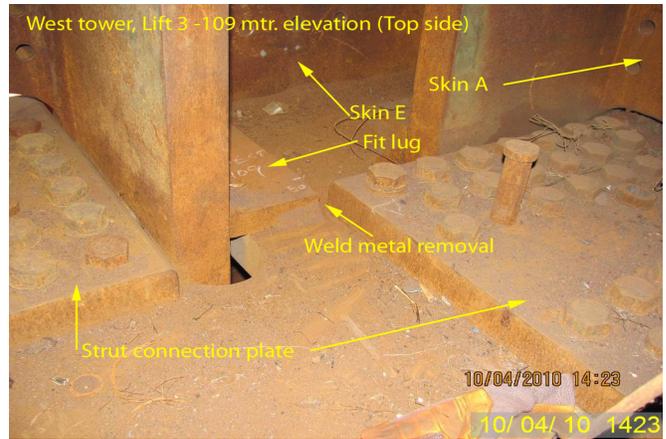
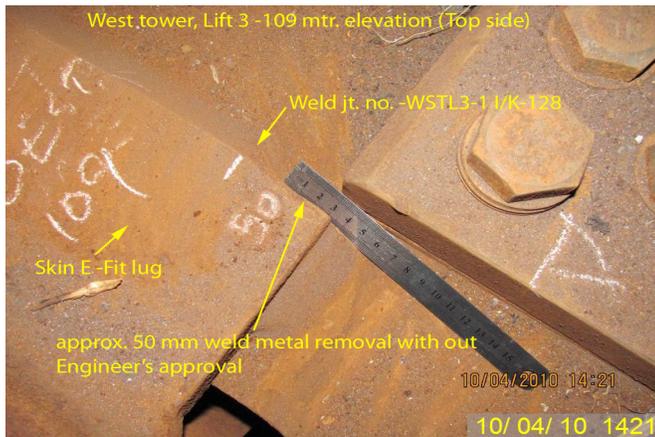
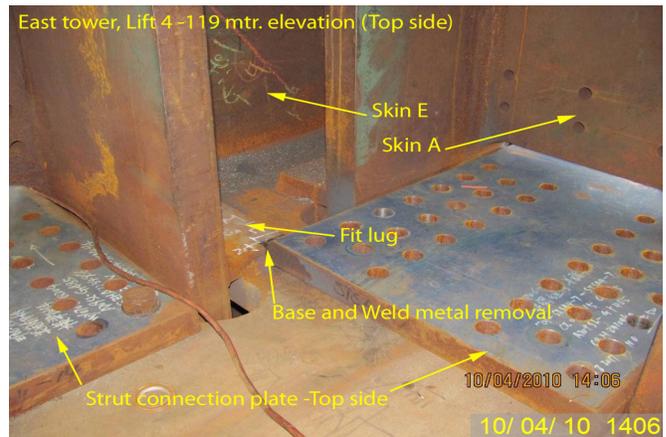
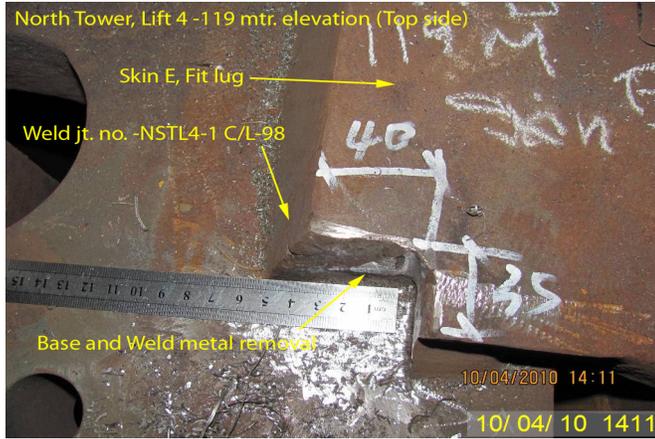
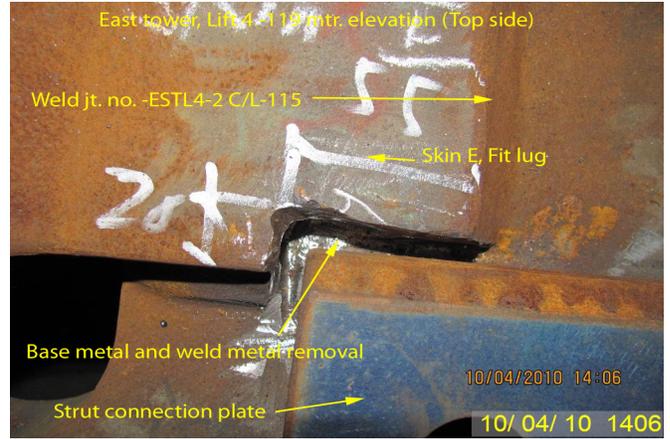
- Approx. 50 mm length, Weld metal Removal observed in Skin E, Fit lug weld, without Engineer's approval.
- The Fit lug found in West Tower, Lift 3- 109 mtr. top diaphragm.
- The Weld joint no. of the fit lug weld found to be WSTL3-1 I / K-128.

- Approx. 55 mm length, Weld metal Removal observed in Skin E, Fit lug weld, Without Engineer's approval.
- The Fit lug found in South Tower, Lift 4- 119 mtr. top diaphragm.
- The Weld joint no. of the fit lug weld found to be SSTL4-1 C/L-98.

AWS D1.5 Section 3.7.5- " The Engineer shall be notified before improperly fitted and welded members are cut apart."

- Approx. 55 mm length, 25 mm width, Weld metal and Base Removal observed in Skin E, Fit lug weld Without Engineer's approval.
- The Fit lug found in East Tower, Lift 4- 119 mtr. top diaphragm.
- The Weld joint no. of the fit lug weld found to be ESTL4-2 C/L-115.

- Approx. 50 mm length, 35 mm width, Weld metal and Base Removal observed in Skin E, Fit lug weld Without Engineer's approval.
- The Fit lug found in North Tower, Lift 4- 119 mtr. top diaphragm.
- The Weld joint no. of the fit lug weld found to be NSTL4-1 C/L-98.

AWS D 1.5 Section 3.7.4 – “Prior approval of the Engineer shall be obtained for repairs to base metal (other than those required by 3.2), repair of major or delayed cracks, repairs to ESW and EGW welds with internal defects, or for a revised design to compensate for deficiencies.”

AWS D1.5 Section 3.7.5- “The Engineer shall be notified before improperly fitted and welded members are cut apart.”
