**DEPARTMENT OF TRANSPORTATION**

Contract #: 04-0120F4Cty: SF/ALA Rte: 80 PM: 13.2/13.9File #: 1.28**WELDING INSPECTION REPORT****Resident Engineer:** Siegenthaler, Peter**Address:** 333 Burma Road**City:** Oakland, CA 94607**Report No:** WIR-017518**Date Inspected:** 18-Oct-2010**Project Name:** SAS Superstructure**OSM Arrival Time:** 1000**Prime Contractor:** American Bridge/Fluor Enterprises, a JV**OSM Departure Time:** 1830**Contractor:** American Bridge/Fluor Enterprises, a JV**Location:** Job Site**CWI Name:** See Below**CWI Present:** Yes No**Inspected CWI report:** Yes No N/A**Rod Oven in Use:** Yes No N/A**Electrode to specification:** Yes No N/A**Weld Procedures Followed:** Yes No N/A**Qualified Welders:** Yes No N/A**Verified Joint Fit-up:** Yes No N/A**Approved Drawings:** Yes No N/A**Approved WPS:** Yes No N/A**Delayed / Cancelled:** Yes No N/A**Bridge No:** 34-0006**Component:** Orthotropic Box Girders**Summary of Items Observed:**

## WELDING INSPECTION REPORT

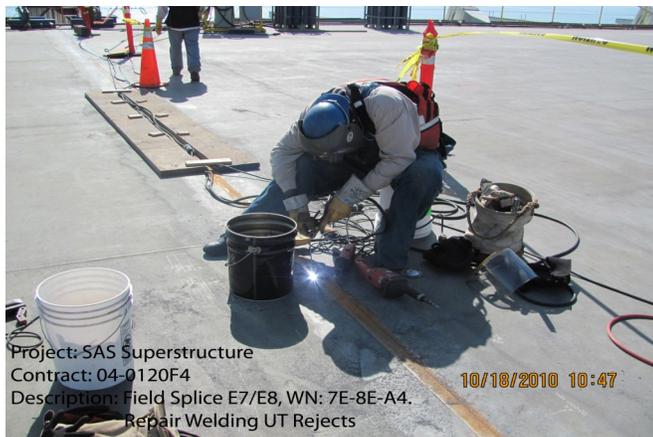
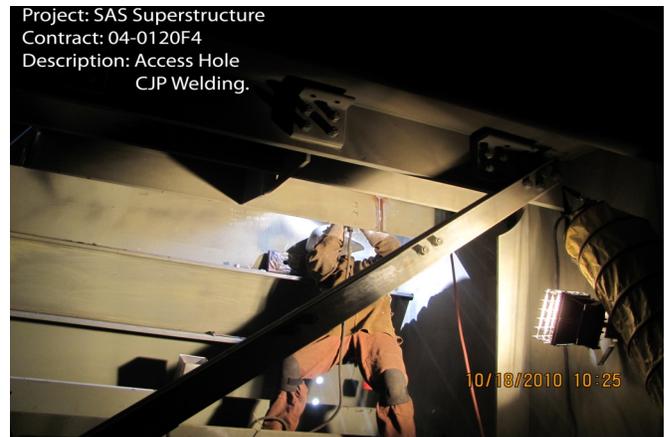
The digital photographs below illustrate the work observed during this scheduled shift.
