DEPARTMENT OF TRANSPORTATION

Contract #: 04-0120F4Cty: SF/ALA Rte: 80 PM: 13.2/13.9File #: 69.28**WELDING INSPECTION REPORT****Resident Engineer:** Siegenthaler, Peter**Address:** 333 Burma Road**City:** Oakland, CA 94607**Report No:** WIR-017536**Date Inspected:** 08-Oct-2010**Project Name:** SAS Superstructure**OSM Arrival Time:** 700**Prime Contractor:** American Bridge/Fluor Enterprises, a JV**OSM Departure Time:** 1900**Contractor:** Zhenhua Port Machinery Company, Ltd (ZPMC), Changxing Island **Location:** Shanghai, China

Bridge No: 34-0006**Component:** Tower & OBG Components**Summary of Items Observed:**

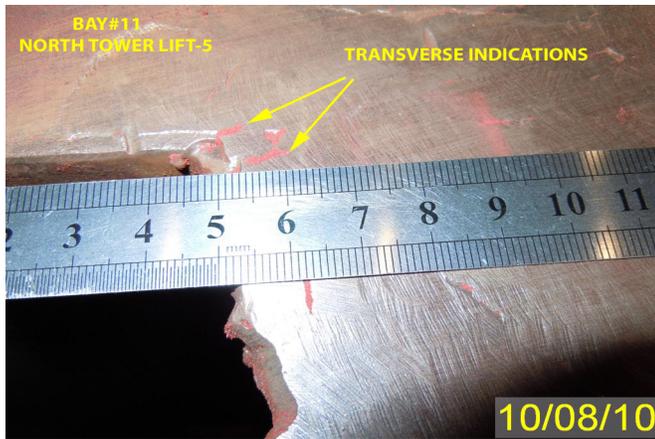
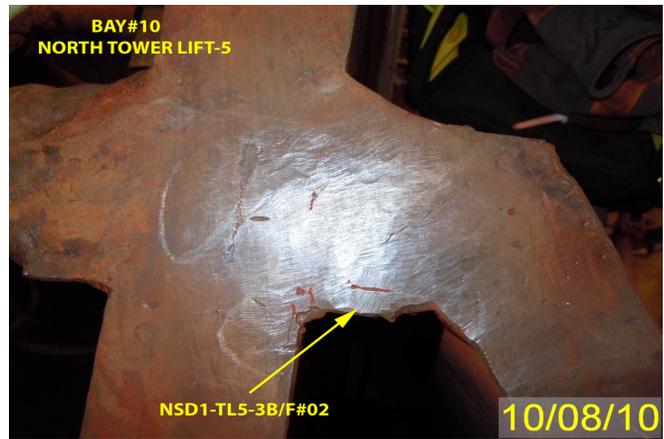
NSD1 – TL5 – 3B/F – 02

This QA inspector performed MT approximately 200 mm length from top of the weld on the backing bar, which was welded full length to the base material. During the process two transverse indications were found on top of the weld. As per ZPMC QC personnel the top and bottom 50 mm of the lift-5 grillage will be machined. The member is identified as TOWER Component. The weld designation reviewed as follows:
