DEPARTMENT OF TRANSPORTATION

Office of Structural Materials

Contract #: 04-0120F4Cty: SF/ALA Rte: 80 PM: 13.2/13.9File #: 69.28**WELDING INSPECTION REPORT****Resident Engineer:** Siegenthaler, Peter**Address:** 333 Burma Road**City:** Oakland, CA 94607**Report No:** WIR-017544**Date Inspected:** 04-Oct-2010**Project Name:** SAS Superstructure**OSM Arrival Time:** 700**Prime Contractor:** American Bridge/Fluor Enterprises, a JV**OSM Departure Time:** 1900**Contractor:** Zhenhua Port Machinery Company, Ltd (ZPMC), Changxing Island **Location:** Shanghai, China**CWI Name:** Mr. Qiu Wen.**CWI Present:** Yes No**Inspected CWI report:** Yes No N/A**Rod Oven in Use:** Yes No N/A**Electrode to specification:** Yes No N/A**Weld Procedures Followed:** Yes No N/A**Qualified Welders:** Yes No N/A**Verified Joint Fit-up:** Yes No N/A**Approved Drawings:** Yes No N/A**Approved WPS:** Yes No N/A**Delayed / Cancelled:** Yes No N/A**Bridge No:** 34-0006**Component:** Tower and Orthotropic Box Girder (OBG)**Summary of Items Observed:**

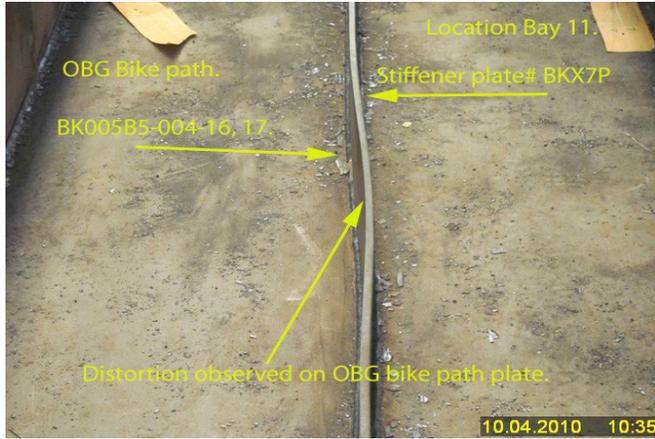
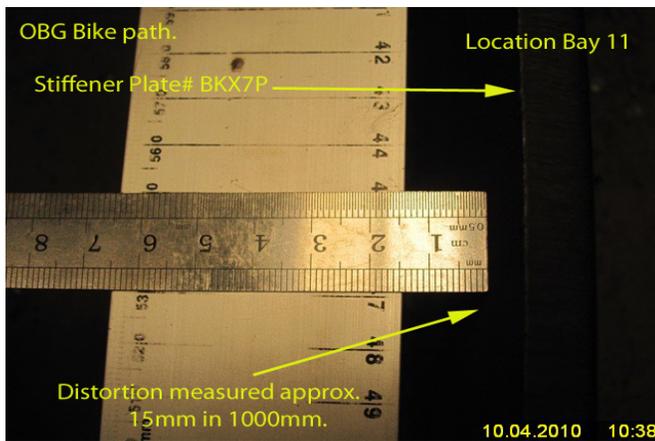
During the Caltrans Quality Assurance in-process observations of the fabrication of OBG Bike path plate BK005B-004, this Quality Assurance Inspector (QA) discovered the following issue, Excessive distortion of a stiffener on the Bike Path BK005B-004. It appears the stiffener was distorted prior to fit-up and welding. The Bike path stiffener identified as BKX7P. The weld is identified as: BK005B5-004-016/017. The distortion measured by this QA inspector is 15mm per 1000mm in Bike path stiffener (BKX7P). The effected stiffener plate is located in between BKX8A and BKX8C stringer plate. The Material thickness for plate is 10 mm. This OBG bike path Plate is located in Sub assembly Bay#11. This QA Inspector generated incident report for this date. For further information, please see the attached pictures below.

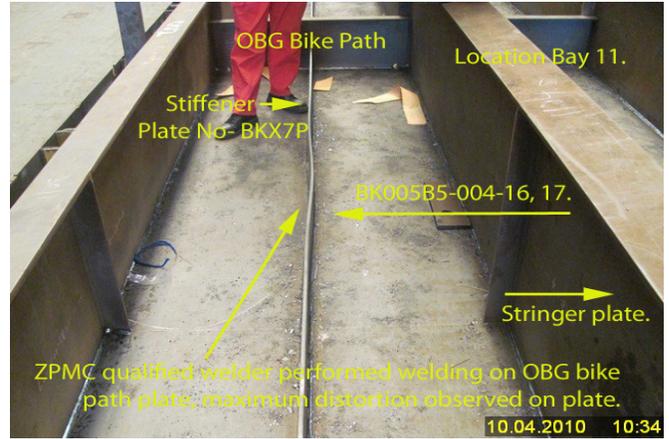
This QA Inspector observed ZPMC qualified welding personnel identified as 054460, 040723, Perform Flux Core Arc Welding (FCAW) on OBG bike path plate. Joint identified as BK005B6-004-041, 042. ZPMC CWI Identified as Yu Dong Ping. The welding parameters as measured using QC's calibrated instrument appeared to be in general compliance with WPS-B-T-2132. For more information see below attached picture number 2.
