DEPARTMENT OF TRANSPORTATION

Contract #: 04-0120F4Cty: SF/ALA Rte: 80 PM: 13.2/13.9File #: 69.28**WELDING INSPECTION REPORT****Resident Engineer:** Siegenthaler, Peter**Address:** 333 Burma Road**City:** Oakland, CA 94607**Report No:** WIR-017560**Date Inspected:** 16-Oct-2010**Project Name:** SAS Superstructure**OSM Arrival Time:** 700**Prime Contractor:** American Bridge/Fluor Enterprises, a JV**OSM Departure Time:** 1900**Contractor:** Zhenhua Port Machinery Company, Ltd (ZPMC), Changxing Island **Location:** Shanghai, China**CWI Name:** Mr. Yu Dong Ping**CWI Present:** Yes No**Inspected CWI report:** Yes No N/A**Rod Oven in Use:** Yes No N/A**Electrode to specification:** Yes No N/A**Weld Procedures Followed:** Yes No N/A**Qualified Welders:** Yes No N/A**Verified Joint Fit-up:** Yes No N/A**Approved Drawings:** Yes No N/A**Approved WPS:** Yes No N/A**Delayed / Cancelled:** Yes No N/A**Bridge No:** 34-0006**Component:** Tower**Summary of Items Observed:**

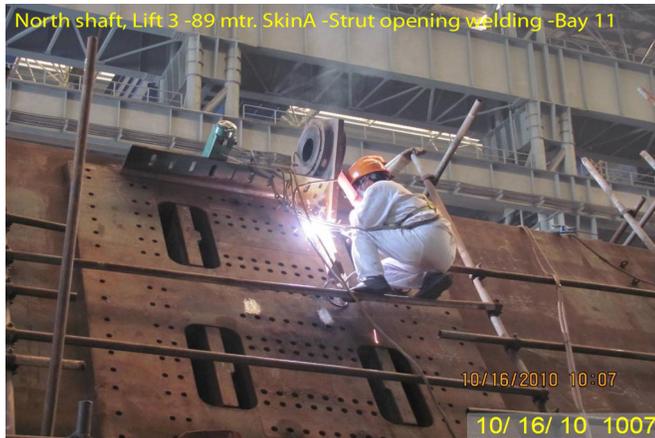
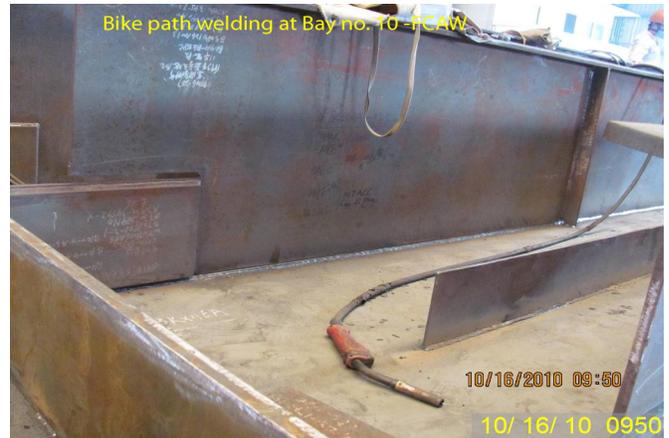
For further information see below pictures:-
