DEPARTMENT OF TRANSPORTATION

Contract #: 04-0120F4Cty: SF/ALA Rte: 80 PM: 13.2/13.9File #: 69.28**WELDING INSPECTION REPORT****Resident Engineer:** Siegenthaler, Peter**Address:** 333 Burma Road**City:** Oakland, CA 94607**Report No:** WIR-017565**Date Inspected:** 21-Oct-2010**Project Name:** SAS Superstructure**OSM Arrival Time:** 1900**Prime Contractor:** American Bridge/Fluor Enterprises, a JV**OSM Departure Time:** 700**Contractor:** Zhenhua Port Machinery Company, Ltd (ZPMC), Changxing Island **Location:** Shanghai, China

Bridge No: 34-0006**Component:** Tower**Summary of Items Observed:**

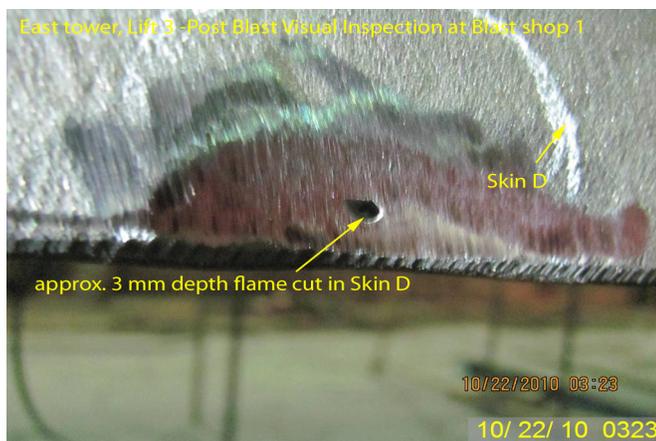
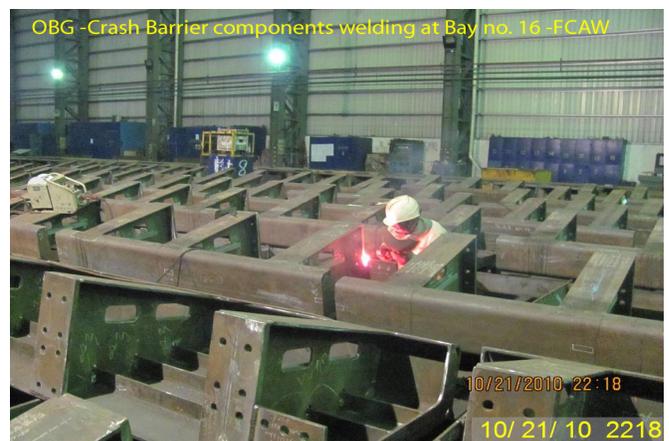
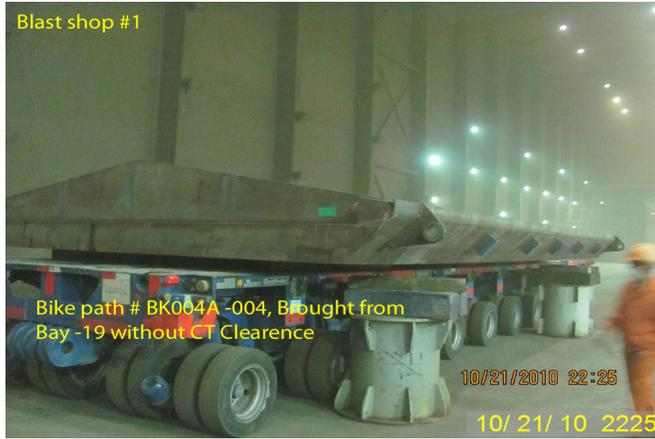
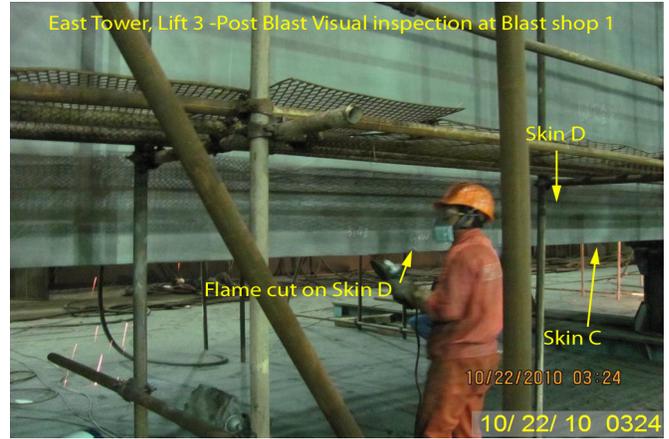
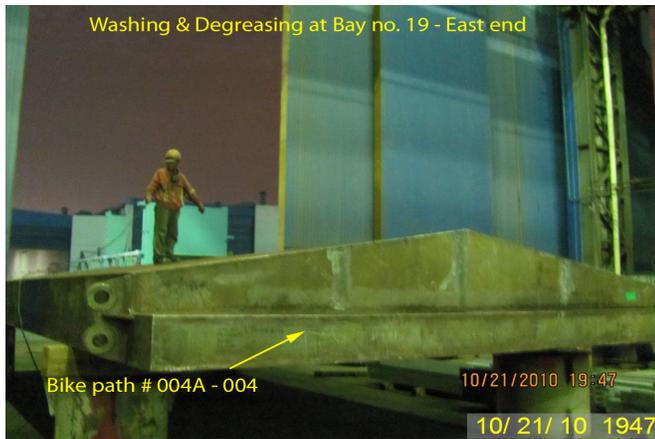
This QA inspector, Baskar Govindarajan, performed Post blast Visual inspection of External surfaces of East tower, Lift 3. All the areas marked which requires grinding, weld repair, Grinding & MT wherever applicable in all the Skins of Tower from 83 to 114 mtr. This inspection was carried out along with QA Inspector Mr. Paul Dawson (B 254). All the marked points shown to ZPMC inspector Mr. Sun Zhi Wang and ABF Inspector Mr. Wang Jiang Hua. All the weld repair areas (2 nos) marked in weld map in detail and the same was signed by ZPMC and ABF Inspector. Incident report rose for the same.
