DEPARTMENT OF TRANSPORTATION

Contract #: 04-0120F4Cty: SF/ALA Rte: 80 PM: 13.2/13.9File #: 1.28**WELDING INSPECTION REPORT****Resident Engineer:** Siegenthaler, Peter**Address:** 333 Burma Road**City:** Oakland, CA 94607**Report No:** WIR-017611**Date Inspected:** 22-Oct-2010**Project Name:** SAS Superstructure**OSM Arrival Time:** 900**Prime Contractor:** American Bridge/Fluor Enterprises, a JV**OSM Departure Time:** 1730**Contractor:** American Bridge/Fluor Enterprises, a JV**Location:** Job Site**CWI Name:** See Below**CWI Present:** Yes No**Inspected CWI report:** Yes No N/A**Rod Oven in Use:** Yes No N/A**Electrode to specification:** Yes No N/A**Weld Procedures Followed:** Yes No N/A**Qualified Welders:** Yes No N/A**Verified Joint Fit-up:** Yes No N/A**Approved Drawings:** Yes No N/A**Approved WPS:** Yes No N/A**Delayed / Cancelled:** Yes No N/A**Bridge No:** 34-0006**Component:** Orthotropic Box Girders**Summary of Items Observed:**

WELDING INSPECTION REPORT

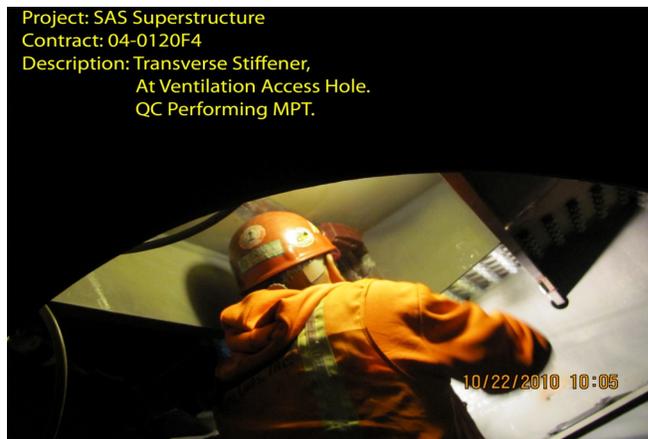
The QAI observed the welder, Xiao Jian Wan ID-9677, perform the CJP groove welding on the transverse stiffener field splice identified as WN: 2E-PP13.5-E2-TS, located at the ventilation access hole. The welder utilized the SMAW process as per the Welding Procedure Specification (WPS) identified as ABF-WPS-D15-1030, Rev.1 and was also utilized by the QC inspector John Pagliero as a reference to monitor welding and verify the DC welding parameters. The amperage was recorded as 120 amps and the minimum preheat of 100 degrees Celsius and the maximum interpass temperature of 230 degrees Celsius was observed and verified. The CJP welding was performed on the "B" face of the joint and was completed during this scheduled shift.

The welding of the transverse stiffeners was performed in the vertical (3G) position with the work placed in an approximately vertical plane and the groove approximately vertical. The welder utilized a slag hammer, pneumatic air gun with an attached chisel and a wire wheel attached to a 4" high cycle grinder to remove slag after deposit of each fill pass. The E-7018-H4R electrode appeared to be in compliance with the contract documents. At the time of the observation no issues were noted by the QAI.
