DEPARTMENT OF TRANSPORTATION

Contract #: 04-0120F4Cty: SF/ALA Rte: 80 PM: 13.2/13.9File #: 1.28**WELDING INSPECTION REPORT****Resident Engineer:** Siegenthaler, Peter**Address:** 333 Burma Road**City:** Oakland, CA 94607**Report No:** WIR-017612**Date Inspected:** 22-Oct-2010**Project Name:** SAS Superstructure**OSM Arrival Time:** 900**Prime Contractor:** American Bridge/Fluor Enterprises, a JV**OSM Departure Time:** 1730**Contractor:** American Bridge/Fluor Enterprises, a JV**Location:** Job Site

| Bridge No: | 34-0006 | | | Component: | Orthotropic Box Girder | | |

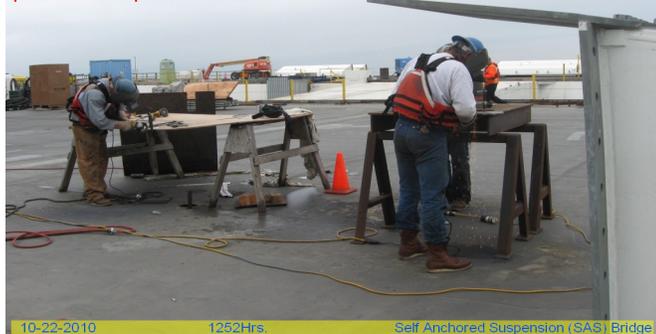
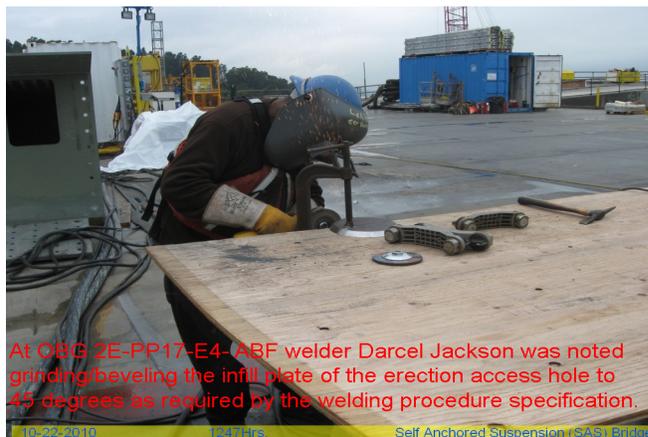
At OBG 2E-PP17-E3- ABF welders Rick Clayborn, Eric Sparks and Ian Smith were noted grinding/beveling the infill plate of the erection access holes to 45 degrees as required by the welding procedure specification.
