DEPARTMENT OF TRANSPORTATION

Contract #: 04-0120F4Cty: SF/ALA Rte: 80 PM: 13.2/13.9File #: 69.28**WELDING INSPECTION REPORT****Resident Engineer:** Siegenthaler, Peter**Address:** 333 Burma Road**City:** Oakland, CA 94607**Report No:** WIR-017639**Date Inspected:** 16-Oct-2010**Project Name:** SAS Superstructure**OSM Arrival Time:** 700**Prime Contractor:** American Bridge/Fluor Enterprises, a JV**OSM Departure Time:** 1900**Contractor:** Zhenhua Port Machinery Company, Ltd (ZPMC), Changxing Island **Location:** Shanghai, China**CWI Name:** Xu Le Feng, Qiu Wen**CWI Present:** Yes No**Inspected CWI report:** Yes No N/A**Rod Oven in Use:** Yes No N/A**Electrode to specification:** Yes No N/A**Weld Procedures Followed:** Yes No N/A**Qualified Welders:** Yes No N/A**Verified Joint Fit-up:** Yes No N/A**Approved Drawings:** Yes No N/A**Approved WPS:** Yes No N/A**Delayed / Cancelled:** Yes No N/A**Bridge No:** 34-0006**Component:** OBG/TOWER**Summary of Items Observed:**

On this day CALTRANS OSM Quality Assurance (QA) Inspector Umesh Gaikwad was present during the times noted above for observations relative to the fabrication of the SAS Superstructure being performed by Zhenhua Port M

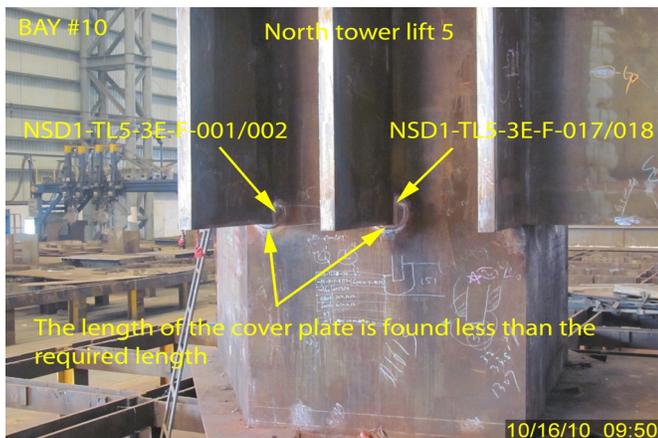
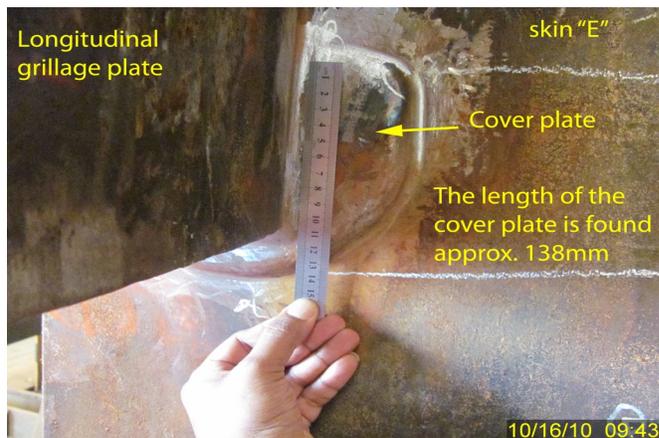
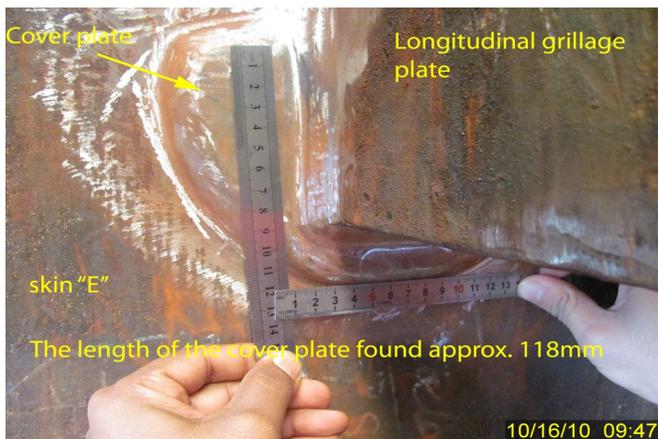
During the Quality Assurance Visual Testing (VT) verification of welds located on Cover Plate for the Longitudinal Grillage plate of North Tower lift 5, this Quality Assurance (QA) Inspector discovered the following issues:

- The dimensions of Cover Plate do not match the approved shop drawings.
- As per shop drawing the required length of the Cover Plate is 151.4mm.
- Cover Plate weld # NSD1-TL5-3E/F-001/002, the length of the Cover Plate was measured as 138mm.
- Cover Plate weld # NSD1-TL5-3E/F-017/018, the length of the Cover Plate was measured as 118mm and 143mm.

- These welds are fillet welds, joining the Cover Plate to the Skin Plate and Longitudinal Grillage plate.
- The member is located in Bay 10.

-Attached photographs provide additional location details.
