Contract #: 04-0120F4Cty: SF/ALA Rte: 80 PM: 13.2/13.9File #: 69.28**WELDING INSPECTION REPORT****Resident Engineer:** Siegenthaler, Peter**Address:** 333 Burma Road**City:** Oakland, CA 94607**Report No:** WIR-017653**Date Inspected:** 28-Oct-2010**Project Name:** SAS Superstructure**OSM Arrival Time:** 700**Prime Contractor:** American Bridge/Fluor Enterprises, a JV**OSM Departure Time:** 1900**Contractor:** Zhenhua Port Machinery Company, Ltd (ZPMC), Changxing Island **Location:** Shanghai, China**CWI Name:** Li Yang**CWI Present:** Yes No**Inspected CWI report:** Yes No N/A**Rod Oven in Use:** Yes No N/A**Electrode to specification:** Yes No N/A**Weld Procedures Followed:** Yes No N/A**Qualified Welders:** Yes No N/A**Verified Joint Fit-up:** Yes No N/A**Approved Drawings:** Yes No N/A**Approved WPS:** Yes No N/A**Delayed / Cancelled:** Yes No N/A**Bridge No:** 34-0006**Component:** OBG Segment**Summary of Items Observed:**

OBG # TRIAL ASSEMBLY YARD (11AE-11BE)

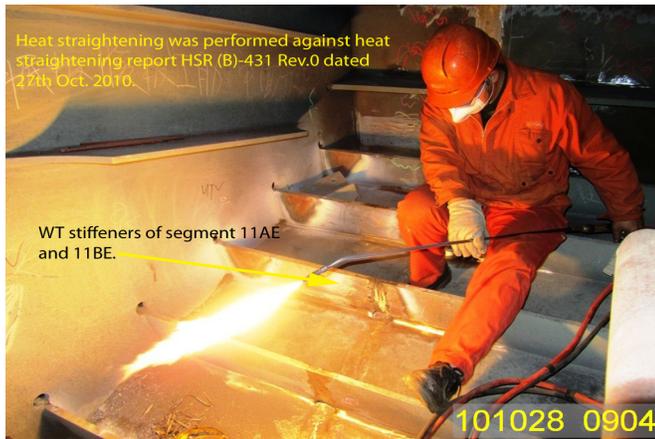
The QA inspector observed the heat straightening operation on weld joint no. 035 on side panel piece mark no. SP699-001. The location was the complete joint penetration groove weld joining the WT stiffeners of segment 11AE and 11BE. The heat straightening was performed against heat straightening report HSR (B)-431 Rev.0 dated 27th Oct. 2010. The heat straightening operation appeared to be in general compliance with the contract specifications.

The QA inspector observed the heat straightening operation on weld joint no. 031 on side panel piece mark no. SP714-001. The location was the complete joint penetration groove weld joining the WT stiffeners of segment 11AE and 11BE. The heat straightening was performed against heat straightening report HSR (B)-431 Rev.0 dated 27th Oct. 2010. The heat straightening operation appeared to be in general compliance with the contract specifications.
