Contract #: 04-0120F4Cty: SF/ALA Rte: 80 PM: 13.2/13.9File #: 69.28**WELDING INSPECTION REPORT****Resident Engineer:** Siegenthaler, Peter**Address:** 333 Burma Road**City:** Oakland, CA 94607**Report No:** WIR-017668**Date Inspected:** 28-Oct-2010**Project Name:** SAS Superstructure**OSM Arrival Time:** 700**Prime Contractor:** American Bridge/Fluor Enterprises, a JV**OSM Departure Time:** 1900**Contractor:** Zhenhua Port Machinery Company, Ltd (ZPMC), Changxing Island **Location:** Shanghai, China**CWI Name:** Li Yang**CWI Present:** Yes No**Inspected CWI report:** Yes No N/A**Rod Oven in Use:** Yes No N/A**Electrode to specification:** Yes No N/A**Weld Procedures Followed:** Yes No N/A**Qualified Welders:** Yes No N/A**Verified Joint Fit-up:** Yes No N/A**Approved Drawings:** Yes No N/A**Approved WPS:** Yes No N/A**Delayed / Cancelled:** Yes No N/A**Bridge No:** 34-0006**Component:** OBG Segments**Summary of Items Observed:**

OBG Trial Assembly Yard

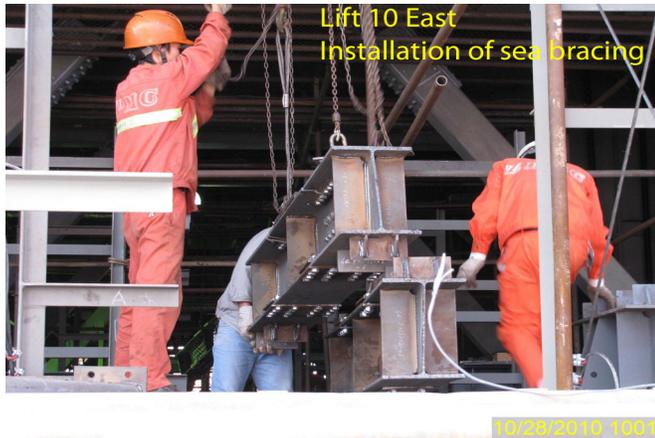
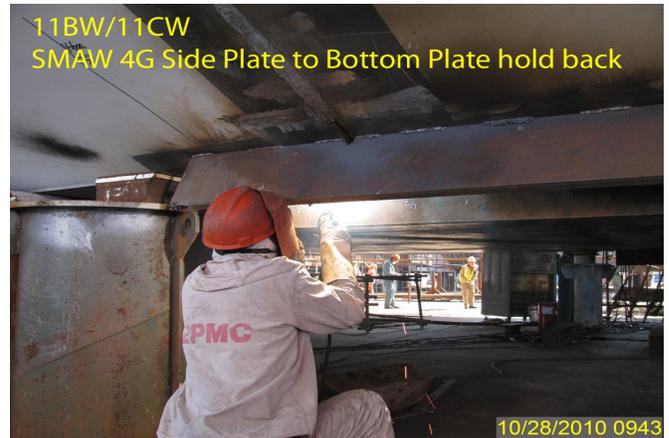
Unless otherwise noted, all work observed on this date appeared to generally comply with applicable contract documents.
