**DEPARTMENT OF TRANSPORTATION**

Contract #: 04-0120F4Cty: SF/ALA Rte: 80 PM: 13.2/13.9File #: 1.28**WELDING INSPECTION REPORT****Resident Engineer:** Siegenthaler, Peter**Address:** 333 Burma Road**City:** Oakland, CA 94607**Report No:** WIR-017702**Date Inspected:** 27-Oct-2010**Project Name:** SAS Superstructure**OSM Arrival Time:** 630**Prime Contractor:** American Bridge/Fluor Enterprises, a JV**OSM Departure Time:** 1500**Contractor:** American Bridge/Fluor Enterprises, a JV**Location:** Job Site**CWI Name:** See below**CWI Present:** Yes No**Inspected CWI report:** Yes No N/A**Rod Oven in Use:** Yes No N/A**Electrode to specification:** Yes No N/A**Weld Procedures Followed:** Yes No N/A**Qualified Welders:** Yes No N/A**Verified Joint Fit-up:** Yes No N/A**Approved Drawings:** Yes No N/A**Approved WPS:** Yes No N/A**Delayed / Cancelled:** Yes No N/A**Bridge No:** 34-0006**Component:** SAS OBG**Summary of Items Observed:**

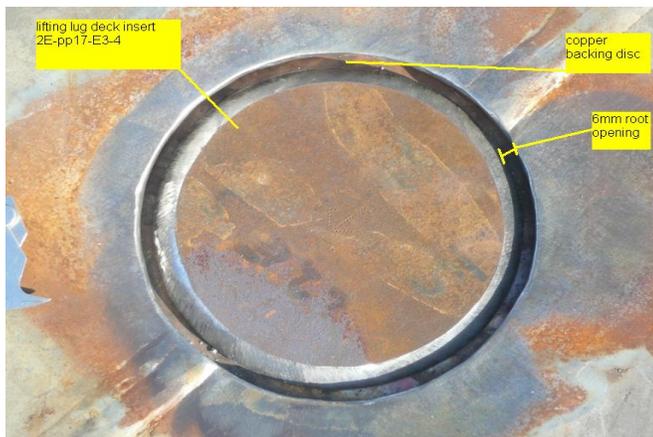
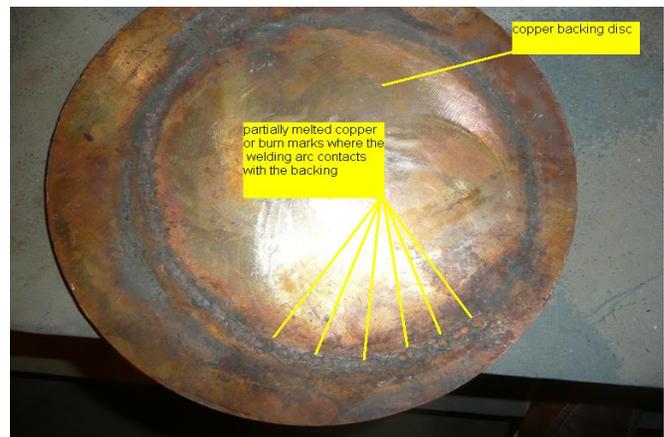
2E-pp15-E3-2

The QA Inspector noted the above identified weld joint was completed previously. The QA Inspector noted the weld joint was not back gouged. The QA Inspector randomly observed the ABF welder complete the top side of the weld joint, remove the copper backing and clean the bottom side of the weld joint with a wire wheel (see summary of conversation). The QA Inspector randomly observed the weld joint was welded with a copper disc on the under side of the weld joint held back 2mm with 4 pieces of 2mm wire. The QA Inspector noted the ABF welder was utilizing a 6mm root opening with a shielded metal arc welding root/fill/cover pass. The QA Inspector randomly observed the ABF welder remove the copper backing and noted the copper disc appeared to be partially melted where the welding arc came into contact with the disc (see picture below). The QA Inspector randomly observed the above identified deck plate insert was ultrasonically tested and two rejects were located. The QA Inspector noted the above identified deck plate insert has not been turn over nor has it been accepted by the SE QC department currently.

The QC Inspector John Pagliero informed the QA Inspector the welder was not going to back gouge the weld joint. The QC Inspector went on to inform the QA Inspector he could not accept the weld due to the fact it was not welded in conformance with ABF-WPS-D1.5-1070. The QA Inspector was later informed by the QC Inspector Mike Johnson the weld would be back gouged at a later date. Later in the shift, Mr. Pagliero was instructed by Mike Johnson no to speak with the QA Inspector Rick Bettencourt or provide any additional information. The QA Inspector noted Mr. Pagliero did in fact provide the QA Inspector with any information that was needed.
