DEPARTMENT OF TRANSPORTATION

Contract #: 04-0120F4Cty: SF/ALA Rte: 80 PM: 13.2/13.9File #: 99.28**WELDING INSPECTION REPORT****Resident Engineer:** Siegenthaler, Peter**Address:** 333 Burma Road**City:** Oakland, CA 94607**Report No:** WIR-017707**Date Inspected:** 03-Nov-2010**Project Name:** SAS Superstructure**OSM Arrival Time:** 700**Prime Contractor:** American Bridge/Fluor Enterprises, a JV**OSM Departure Time:** 1900**Contractor:** Zhenhua Port Machinery Company, Ltd (ZPMC)**Location:** Shanghai, China

Bridge No: 34-0006**Component:** OBG Trial Assembly**Summary of Items Observed:**

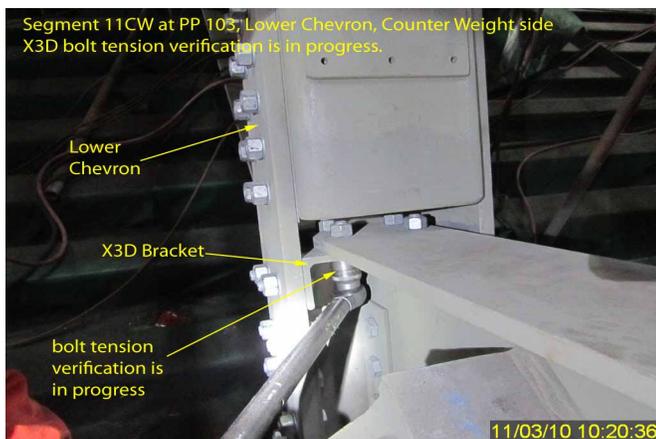
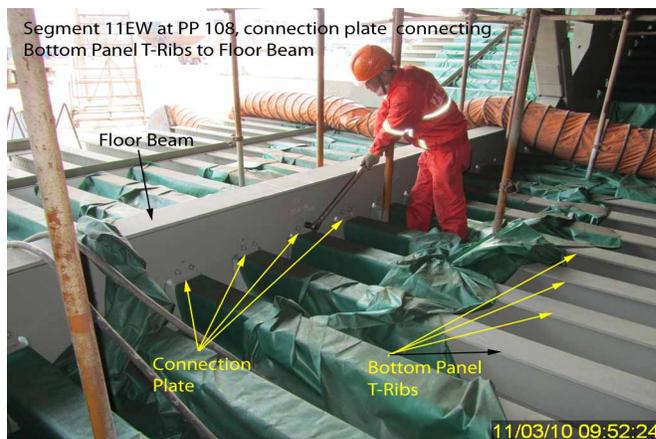
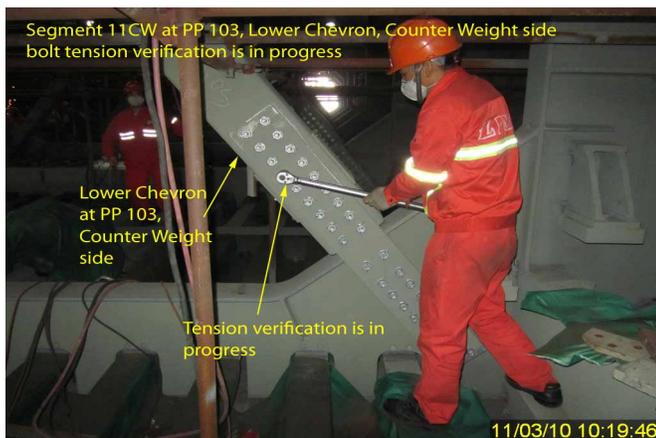
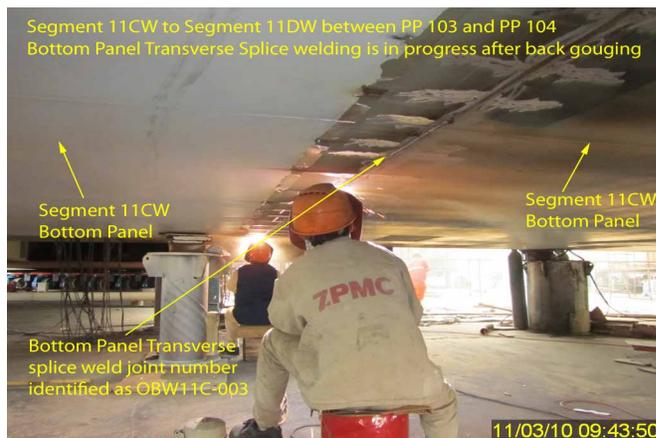
This Quality Assurance (QA) Inspector witnessed final bolt tension verification for Lower Chevron, Upper Chevron, X3D Bracket connected to floor beam flange and to the splice plate and H-Beam connecting the floor beam and splice plate at Panel Point (PP) 101, PP 102 and PP 103 for Segment 11CW at Counter Weight and Cross Beam side. Inspected 10% on a random basis and found the tension to be in general compliance. Inspection was performed against the Notification No. 00536 Dated November 03, 2010.

This QA Inspector witnessed the final bolt tension verification on bolts connecting the T-Rib connections plates at Side Panel (Counter Weight and Cross Beam side) and at Bottom Panel at the Panel Points (PP) 107 and PP 108 for Segment 11EW. The QA Inspector verified the bolt tension on a random basis and the results appeared to be in general compliance. The Inspection was performed against Notification No. 00536 dated November 03, 2010.
