DEPARTMENT OF TRANSPORTATION

Contract #: 04-0120F4Cty: SF/ALA Rte: 80 PM: 13.2/13.9File #: 69.28**WELDING INSPECTION REPORT****Resident Engineer:** Siegenthaler, Peter**Address:** 333 Burma Road**City:** Oakland, CA 94607**Report No:** WIR-017717**Date Inspected:** 19-Oct-2010**Project Name:** SAS Superstructure**OSM Arrival Time:** 700**Prime Contractor:** American Bridge/Fluor Enterprises, a JV**OSM Departure Time:** 1900**Contractor:** Zhenhua Port Machinery Company, Ltd (ZPMC), Changxing Island **Location:** Shanghai, China**CWI Name:** Xu Le Feng**CWI Present:** Yes No**Inspected CWI report:** Yes No N/A**Rod Oven in Use:** Yes No N/A**Electrode to specification:** Yes No N/A**Weld Procedures Followed:** Yes No N/A**Qualified Welders:** Yes No N/A**Verified Joint Fit-up:** Yes No N/A**Approved Drawings:** Yes No N/A**Approved WPS:** Yes No N/A**Delayed / Cancelled:** Yes No N/A**Bridge No:** 34-0006**Component:** TOWER & OBG Components**Summary of Items Observed:**

SOUTH TOWER LIFT-3, 89 M DIAPHRAGM (BOTTOM) PIPE RAIL

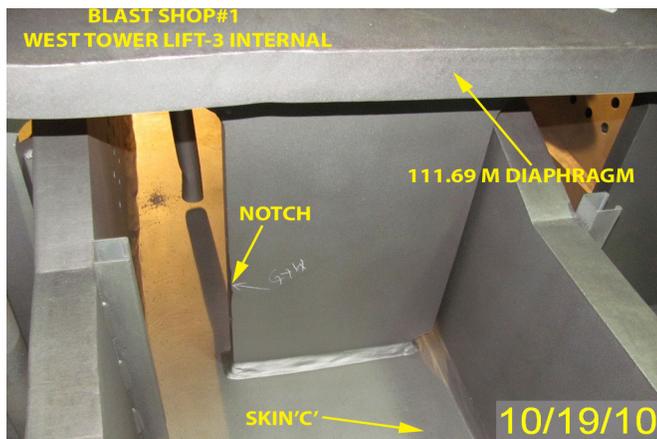
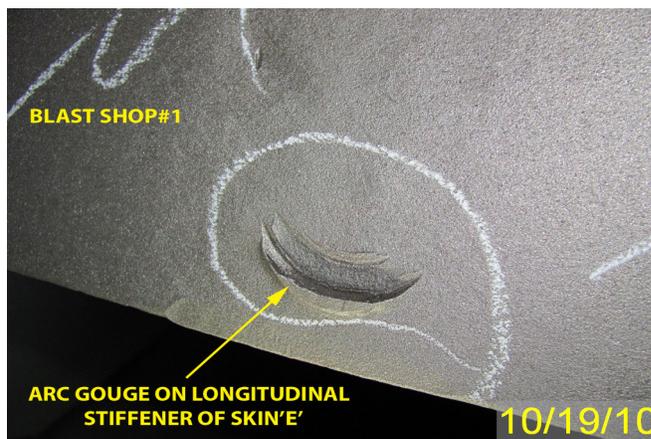
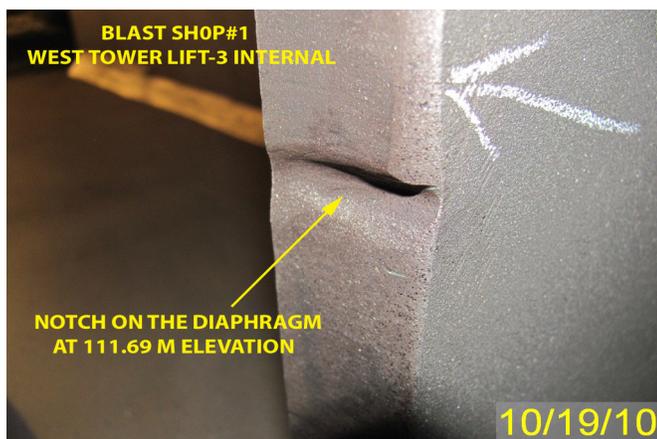
During the Internal pre-blast visual inspection on West tower Lift-3, this Quality Assurance Inspector (QA) discovered the defects required welding and Magnetic particle testing on weld and base material at the following locations:

- 1) Skin 'A' – Arc Gouge –approximately 1000 mm from 102.5 M diaphragm in between 1st and 2nd stiffeners.
- 2) Skin 'B' – Porosity – fit-lug weld on 1st stiffener from skin 'C'.

- 3) Skin 'A' – Under-fill – 105.5 M diaphragm fit-lug weld on 1st stiffener from skin 'E'.
- 4) Skin 'D' – Porosity – 105.5 M diaphragm fit-lug weld on 2nd stiffener from skin 'C'.

- 5) Skin 'D' – Porosity – 105.5 M diaphragm fit-lug weld on 3rd stiffener from skin 'C'.
- 6) Skin 'D' – Porosity – 105.5 M diaphragm fit-lug weld on 4th stiffener from skin 'C'.

- 7) Skin 'A' – Porosity – 102.5 M diaphragm to skin weld near cope hole.
- 8) Skin 'D' – Porosity – 109 M diaphragm (Bottom) to skin weld, close to 2nd stiffener from skin 'E'.

- 9) Skin 'E' – Porosity – 109 M diaphragm (Bottom) fit-lug weld on 1st stiffener from skin 'D'.
- 10) Skin 'C' – Notch – 111.69 M diaphragm close to 1st stiffener from skin 'B' and approximately 160 mm from skin 'C'.

- 11) Skin 'B' – Arc gouge – 111.69 M diaphragm top of the 1st Longitudinal stiffener from Skin 'C'.
- 12) Skin 'E' – Arc gouge – top of the 1st Longitudinal stiffener from Skin 'D' and approximately 500 mm from 111.69 M diaphragm.
