**DEPARTMENT OF TRANSPORTATION**

Contract #: 04-0120F4Cty: SF/ALA Rte: 80 PM: 13.2/13.9File #: 69.28**WELDING INSPECTION REPORT****Resident Engineer:** Siegenthaler, Peter**Address:** 333 Burma Road**City:** Oakland, CA 94607**Report No:** WIR-017731**Date Inspected:** 26-Oct-2010**Project Name:** SAS Superstructure**OSM Arrival Time:** 700**Prime Contractor:** American Bridge/Fluor Enterprises, a JV**OSM Departure Time:** 1900**Contractor:** Zhenhua Port Machinery Company, Ltd (ZPMC), Changxing Island **Location:** Shanghai, China**CWI Name:** Zhu Feng**CWI Present:** Yes No**Inspected CWI report:** Yes No N/A**Rod Oven in Use:** Yes No N/A**Electrode to specification:** Yes No N/A**Weld Procedures Followed:** Yes No N/A**Qualified Welders:** Yes No N/A**Verified Joint Fit-up:** Yes No N/A**Approved Drawings:** Yes No N/A**Approved WPS:** Yes No N/A**Delayed / Cancelled:** Yes No N/A**Bridge No:** 34-0006**Component:** TOWER & OBG Components**Summary of Items Observed:**

# WELDING INSPECTION REPORT

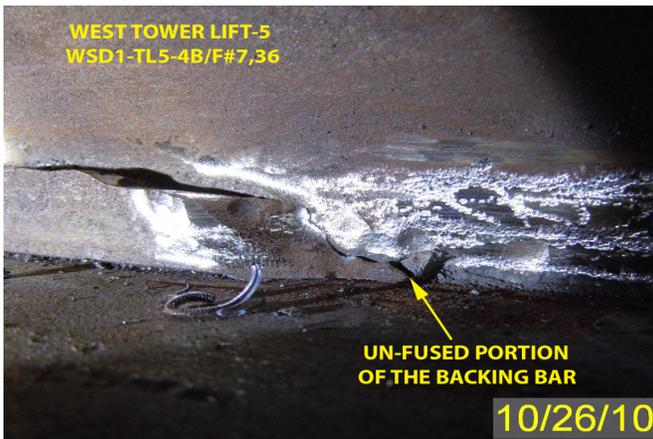
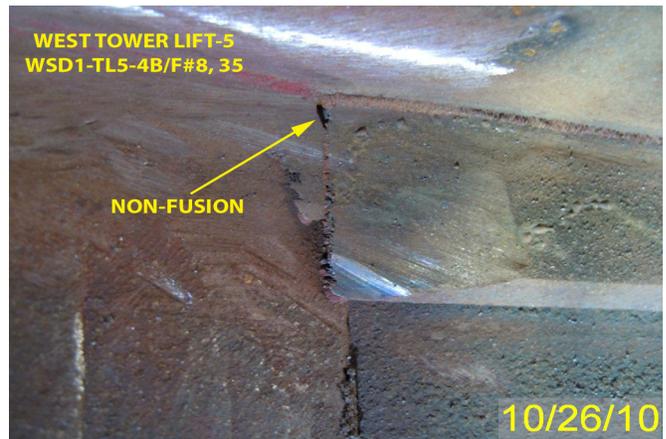
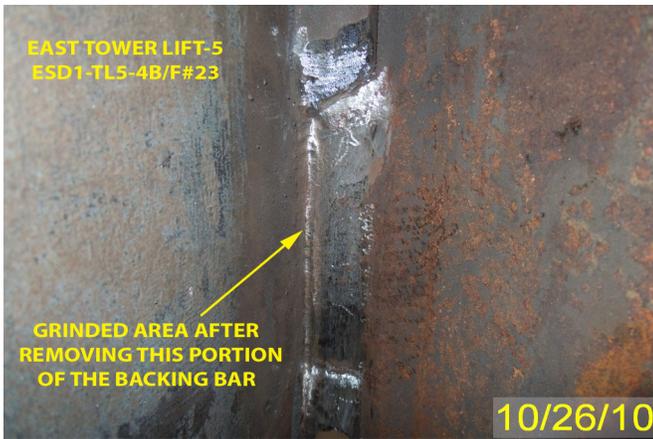
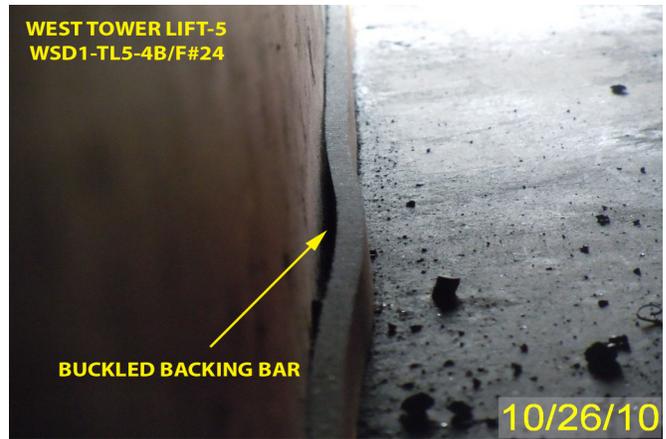
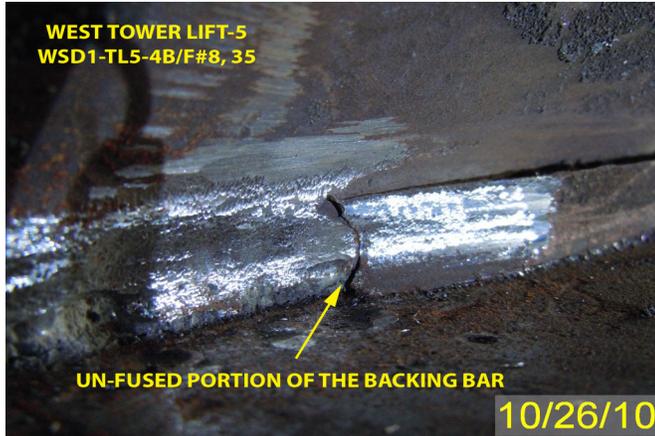
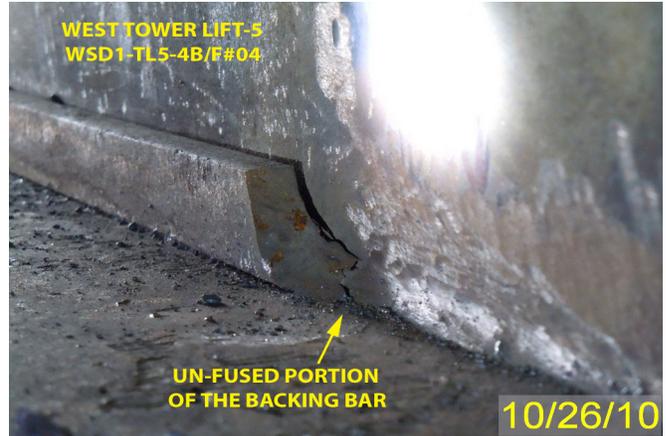
During the Caltrans Quality Assurance (QA) in-process observation on East and West tower lift-5 grillages; this QA Inspector discovered the following issues:

-West tower Lift-5 issues:-

1. Non-Fused backing bar – WSD1-TL5-4B/F#7,36
2. Non-Fused backing bar – WSD1-TL5-4B/F#8,35
3. Non-Fused backing bar – WSD1-TL5-4B/F#24
4. Buckled backing bar – WSD1-TL5-4B/F#4

-East tower Lift-5 issue:-

1. Removed portion of the backing requires welding – ESD1-TL5-2B/F#23

-Above mentioned welds are T-joint complete joint penetration (CJP) welds.

-As per the RFI-002099R0 and AWS D1.5 the groove welds made with steel backing shall have the weld metal thoroughly fused and weld the cavity after removal of the backing bar to build-up the surface and match the backing bar geometry.

AWD 1.5 2002, Section 3.13.2: “Groove welds made with the use of steel backing shall have the weld metal

thoroughly fused with the backing.”

RFI-002099R0: “Repair the blow-through by gouging the backing bar and deck weld to sound metal, followed by grinding to provide a sloped area suitable for welding. Then weld the cavity, building up the surface to match the backing bar geometry. After welding, grind the weld in to approximate shape of the backing to smoothly blend to the unaffected backing.”
