**DEPARTMENT OF TRANSPORTATION**

Contract #: 04-0120F4Cty: SF/ALA Rte: 80 PM: 13.2/13.9File #: 69.28**WELDING INSPECTION REPORT****Resident Engineer:** Siegenthaler, Peter**Address:** 333 Burma Road**City:** Oakland, CA 94607**Report No:** WIR-017743**Date Inspected:** 02-Nov-2010**Project Name:** SAS Superstructure**OSM Arrival Time:** 700**Prime Contractor:** American Bridge/Fluor Enterprises, a JV**OSM Departure Time:** 1900**Contractor:** Zhenhua Port Machinery Company, Ltd (ZPMC), Changxing Island **Location:** Shanghai, China**CWI Name:** Yu Dong Ping, Xu Le Feng**CWI Present:** Yes No**Inspected CWI report:** Yes No N/A**Rod Oven in Use:** Yes No N/A**Electrode to specification:** Yes No N/A**Weld Procedures Followed:** Yes No N/A**Qualified Welders:** Yes No N/A**Verified Joint Fit-up:** Yes No N/A**Approved Drawings:** Yes No N/A**Approved WPS:** Yes No N/A**Delayed / Cancelled:** Yes No N/A**Bridge No:** 34-0006**Component:** OBG/TOWER**Summary of Items Observed:**

BAY 11, OBG BIKE PATH (NWIT # 07200)

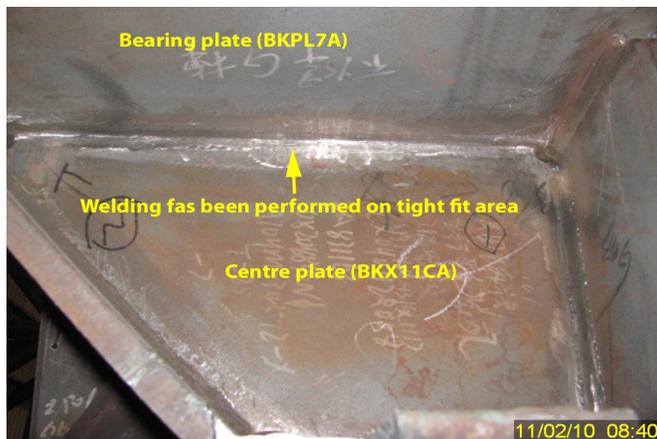
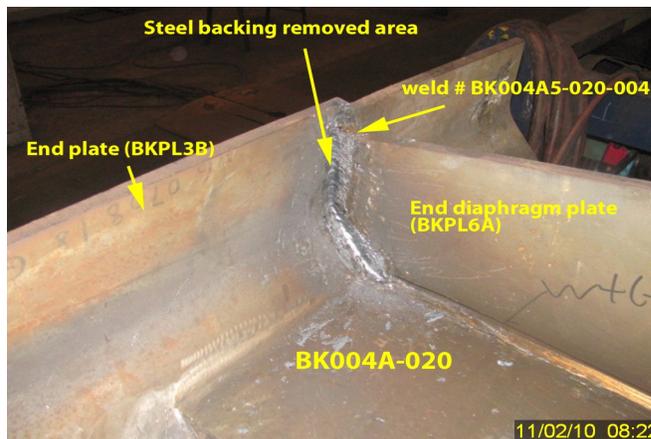
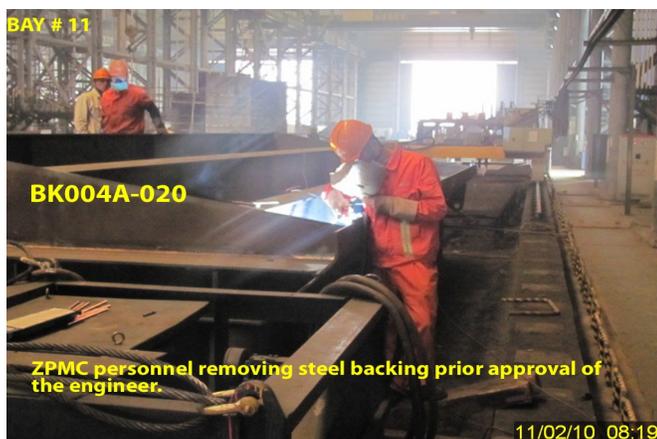
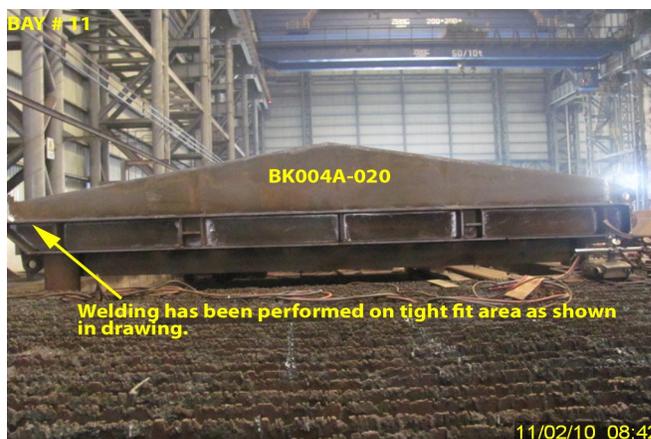
- The welding/tack welding has been performed on the tight fit area as shown in drawing.
- The parts are joining the Bearing Plate (BKPL7A/B) and 25mm centre plates (BKX11B, BKX11CA & BKX11DA).
- The member is located in bay 11.

- Steel backing has been removed by using Air Carbon Arc gouging prior approval of engineer.
- The weld is Complete Joint Penetration (CJP) with steel backing joining the End Diaphragm Plate (BKPL6A) and End Plate (BKPL3A/B) of bike path.
- The welds are identified as: BK004A5-020-004 and BK004A3-020-005.
- The member is located in bay 11.
