DEPARTMENT OF TRANSPORTATION

Contract #: 04-0120F4Cty: SF/ALA Rte: 80 PM: 13.2/13.9File #: 99.28**WELDING INSPECTION REPORT****Resident Engineer:** Siegenthaler, Peter**Address:** 333 Burma Road**City:** Oakland, CA 94607**Report No:** WIR-017747**Date Inspected:** 02-Nov-2010**Project Name:** SAS Superstructure**OSM Arrival Time:** 700**Prime Contractor:** American Bridge/Fluor Enterprises, a JV**OSM Departure Time:** 1900**Contractor:** Zhenhua Port Machinery Company, Ltd (ZPMC)**Location:** Shanghai, China**CWI Name:** Li Yang and Zhu Zhong Hai**CWI Present:** Yes No**Inspected CWI report:** Yes No N/A**Rod Oven in Use:** Yes No N/A**Electrode to specification:** Yes No N/A**Weld Procedures Followed:** Yes No N/A**Qualified Welders:** Yes No N/A**Verified Joint Fit-up:** Yes No N/A**Approved Drawings:** Yes No N/A**Approved WPS:** Yes No N/A**Delayed / Cancelled:** Yes No N/A**Bridge No:** 34-0006**Component:** OBG Trial Assembly**Summary of Items Observed:**

Orthotropic Box Girder (OBG) at Trial Assembly Areas

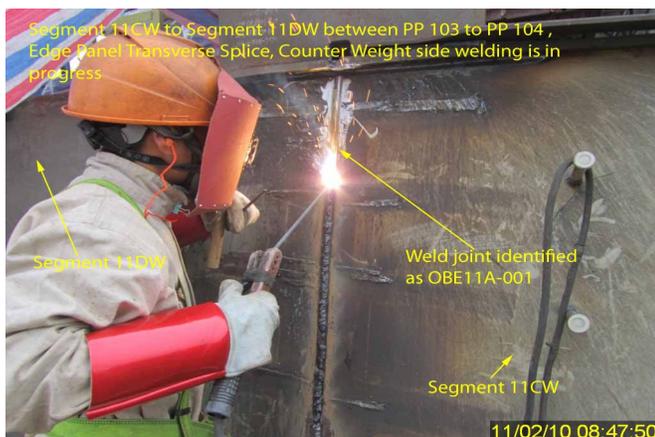
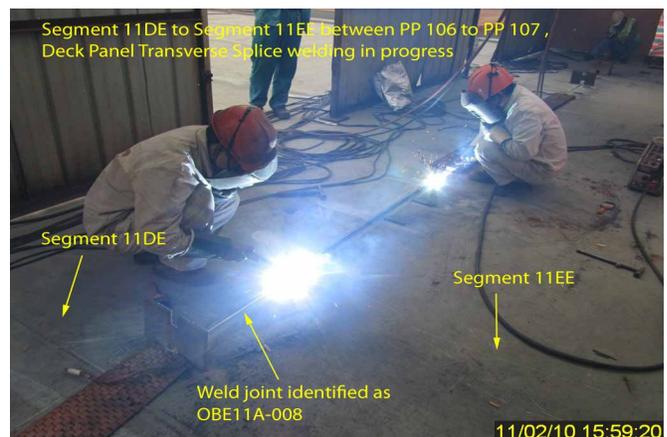
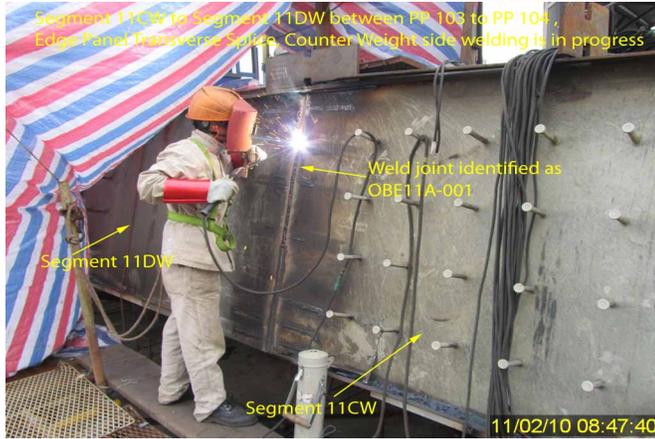
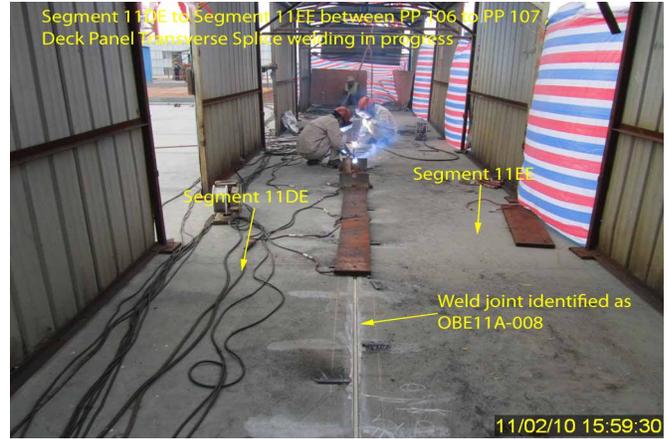
This QA Inspector observed the in-process welding by Shielded Metal Arc Welding (SMAW) process on a Complete Joint Penetration (CJP) groove weld. The Weld joint was designated as OBW11A-001. The welder identification was 046709 and was observed welding in the 4G (Overhead) position using approved Welding Procedure Specification WPS-B-P-2214-B-U2-FCM-1. The piece mark was identified as the edge panel splice weld, Counter Weight side.

This QA Inspector observed the in-process welding by Flux Cored Arc Welding (FCAW) process on a Complete Joint Penetration (CJP) groove weld. The Weld joint was designated as OBW11A-008. The welder identification were 047313, 044473 and 040367 and was observed welding in the 1G (Flat) position using approved Welding Procedure Specification WPS-B-T-223(2)1T-1. The piece mark was identified as the Deck Panel, transverse splice weld.

This QA Inspector observed the in-process welding by Shielded Metal Arc Welding (SMAW) process on a Complete Joint Penetration (CJP) groove weld. The Weld joint was designated as OBE11B-007. The welder identification was 040320 and observed welding in the 4G (Overhead) position using approved Welding Procedure Specification WPS-B-P-2214-B-U2-FCM-1. The piece mark was identified as the Side Panel, transverse splice Cross Beam side.
