DEPARTMENT OF TRANSPORTATION

Contract #: 04-0120F4Cty: SF/ALA Rte: 80 PM: 13.2/13.9File #: 69.28**WELDING INSPECTION REPORT****Resident Engineer:** Siegenthaler, Peter**Address:** 333 Burma Road**City:** Oakland, CA 94607**Report No:** WIR-017749**Date Inspected:** 01-Nov-2010**Project Name:** SAS Superstructure**OSM Arrival Time:** 700**Prime Contractor:** American Bridge/Fluor Enterprises, a JV**OSM Departure Time:** 1900**Contractor:** Zhenhua Port Machinery Company, Ltd (ZPMC), Changxing Island **Location:** Shanghai, China**CWI Name:** Liu Hua Jie**CWI Present:** Yes No**Inspected CWI report:** Yes No N/A**Rod Oven in Use:** Yes No N/A**Electrode to specification:** Yes No N/A**Weld Procedures Followed:** Yes No N/A**Qualified Welders:** Yes No N/A**Verified Joint Fit-up:** Yes No N/A**Approved Drawings:** Yes No N/A**Approved WPS:** Yes No N/A**Delayed / Cancelled:** Yes No N/A**Bridge No:** 34-0006**Component:** Orthotropic Box Girder (OBG)**Summary of Items Observed:**

OBG TRIAL ASSEMBLY YARD**WELDING:****Segment 11CE ~ 11DE**

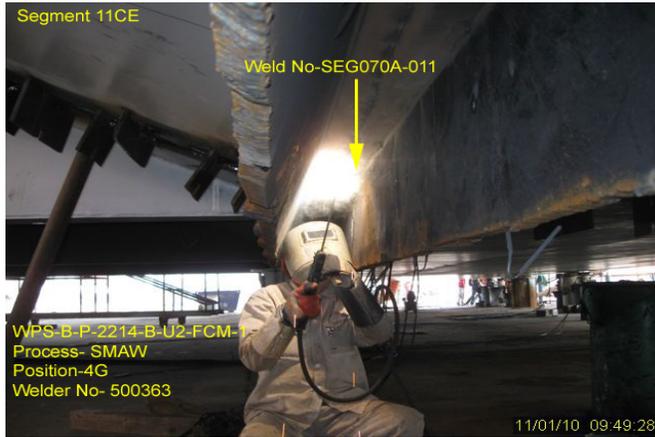
This QA Inspector observed ZPMC qualified welding personnel identified as 500363 perform Shielded Metal Arc Welding (SMAW), weld joint identified as SEG070A-011; located On Orthotropic Box Girder (OBG) Side Plate to Bottom Plate Transverse CJP Weld; ZPMC Quality Control (QC) is identified as Mr. Wang Li Yang. The welding variables recorded by QC appeared to comply with applicable WPS-B-P-2214-B-U2-FCM-1. See attached photo for further details.

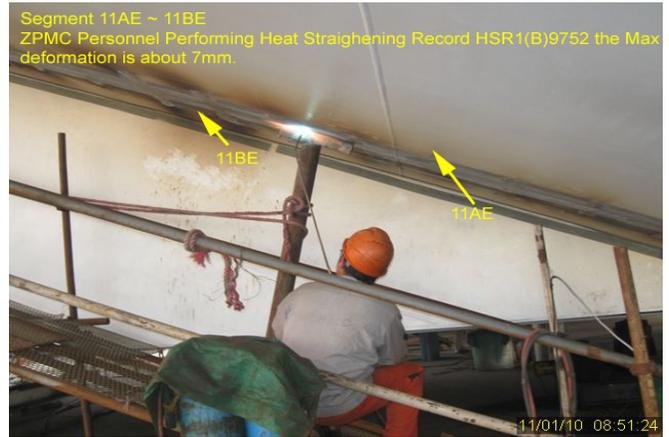
ZPMC personnel heat straightening Orthotropic Box Girder (OBG) member identified as Side Plate to Side Plate Transverse CJP Weld. Distortion appeared to be caused by Welding. ZPMC Quality Control (QC) inspector identified as Mr. Wang Li Yang was present to monitor the heat straightening process. The heat straightening appeared to comply with Heat Straightening Report HSR1 (B) 9752. See attached photo for further details.
