Contract #: 04-0120F4Cty: SF/ALA Rte: 80 PM: 13.2/13.9File #: 1.28**WELDING INSPECTION REPORT****Resident Engineer:** Siegenthaler, Peter**Address:** 333 Burma Road**City:** Oakland, CA 94607**Report No:** WIR-017757**Date Inspected:** 29-Oct-2010**Project Name:** SAS Superstructure**OSM Arrival Time:** 630**Prime Contractor:** American Bridge/Fluor Enterprises, a JV**OSM Departure Time:** 1500**Contractor:** American Bridge/Fluor Enterprises, a JV**Location:** Job Site**CWI Name:** See Below**CWI Present:** Yes No**Inspected CWI report:** Yes No N/A**Rod Oven in Use:** Yes No N/A**Electrode to specification:** Yes No N/A**Weld Procedures Followed:** Yes No N/A**Qualified Welders:** Yes No N/A**Verified Joint Fit-up:** Yes No N/A**Approved Drawings:** Yes No N/A**Approved WPS:** Yes No N/A**Delayed / Cancelled:** Yes No N/A**Bridge No:** 34-0006**Component:** Orthotropic Box Girders**Summary of Items Observed:**

WELDING INSPECTION REPORT

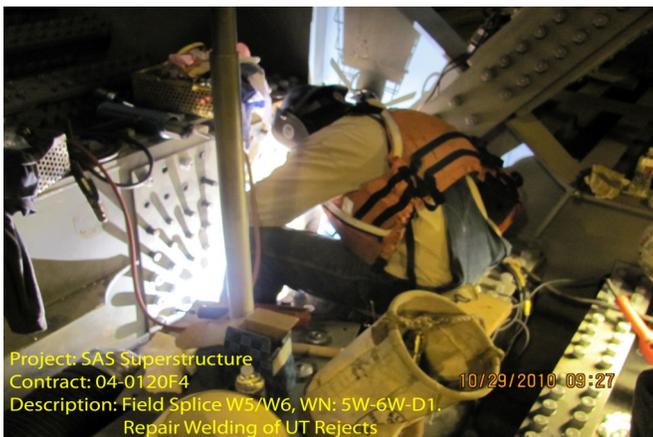
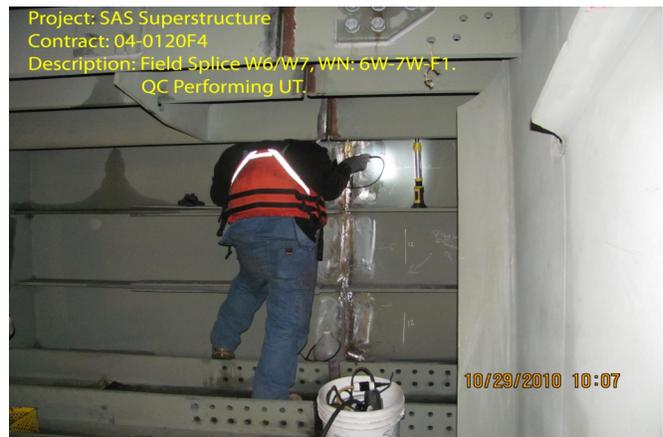
The QAI observed the excavation of the unacceptable discontinuities on the deck plate field splice identified as WN: 5W-6W-D1, repair cycle # R1. The rejectable discontinuities was discovered during the Ultrasonic Testing (UT) performed by the QC technician, Jesse Cayabyab and appeared to travel in the longitudinal direction of the weld axis. The excavations of the rejected areas was performed by AB/F personnel Ken Chappell utilizing a high cycle grinder to remove the defects and a rotary file to bring the excavated area into compliance with the Weld Procedure Specification (WPS) ABF-WPS-D15-1001 Repair, Rev. 0. At the conclusion of the excavations the QAI observed the QC inspector, Jesse Cayabyab, performed a visual inspection and a Magnetic Particle Test (MPT) of the excavated areas and no rejectable indications were noted. At the conclusion of the VT and MPT, the welder commenced the welding of the repair which was identified with the following Y coordinate; Y=100 mm. The welding was performed by Fred Kaddu ID-2188 utilizing the Shielded Metal Arc Welding (SMAW) process as per the WPS which was also utilized by the QC inspector to monitor the welding and to verify the DC welding parameters. The QC inspector verified the DC welding parameters as 122 amps and the minimum preheat temperature of 40 degrees Celsius and the maximum interpass temperature of 230 degrees Celsius appeared to

comply with the contract documents. The welding was performed in the flat (1G) position utilizing a 3.2 mm low hydrogen electrode. The welding of this repair was completed during the scheduled shift. The QAI also verified the dimensions of the excavations and were noted and recorded as follows; Y=100 mm, L=90 mm, d=10 mm and Y=1340 mm, L=150 mm, d=11 mm.

The QAI observed the Ultrasonic Testing (UT) of the Complete Joint Penetration (CJP) on the edge plate field splice identified as WN: 6W-7W-F1. The testing was performed by the QC technician Jesse Cayabyab utilizing a G.E./Krautkramer USM 35X. The examination was conducted utilizing UT Procedure identified as SE-UT-D1. 5-CT-100 Rev.4 and the applicable contract documents. The QC technician performed the required longitudinal wave technique, utilizing a 25.4mm diameter transducer, to perform the examination for base metal soundness and the shear wave technique for the examination of weld soundness which was performed utilizing a 16mm x 19mm rectangular transducer. The testing was not completed during this shift.

The QAI also observed the back gouging on the "B" face of the single-v-groove weld identified as Weld Number (WN): 6W-7W-C1 and C2. The back gouging was performed the welder, Rory Hogan ID-3186, utilizing the plasma arc cutting method.

The digital photographs below illustrate the work observed during this scheduled shift.
