DEPARTMENT OF TRANSPORTATION

Contract #: 04-0120F4Cty: SF/ALA Rte: 80 PM: 13.2/13.9File #: 1.28**WELDING INSPECTION REPORT****Resident Engineer:** Siegenthaler, Peter**Address:** 333 Burma Road**City:** Oakland, CA 94607**Report No:** WIR-017759**Date Inspected:** 01-Nov-2010**Project Name:** SAS Superstructure**OSM Arrival Time:** 630**Prime Contractor:** American Bridge/Fluor Enterprises, a JV**OSM Departure Time:** 1500**Contractor:** American Bridge/Fluor Enterprises, a JV**Location:** Job Site**CWI Name:** See Below**CWI Present:** Yes No**Inspected CWI report:** Yes No N/A**Rod Oven in Use:** Yes No N/A**Electrode to specification:** Yes No N/A**Weld Procedures Followed:** Yes No N/A**Qualified Welders:** Yes No N/A**Verified Joint Fit-up:** Yes No N/A**Approved Drawings:** Yes No N/A**Approved WPS:** Yes No N/A**Delayed / Cancelled:** Yes No N/A**Bridge No:** 34-0006**Component:** Orthotropic Box Girders**Summary of Items Observed:**

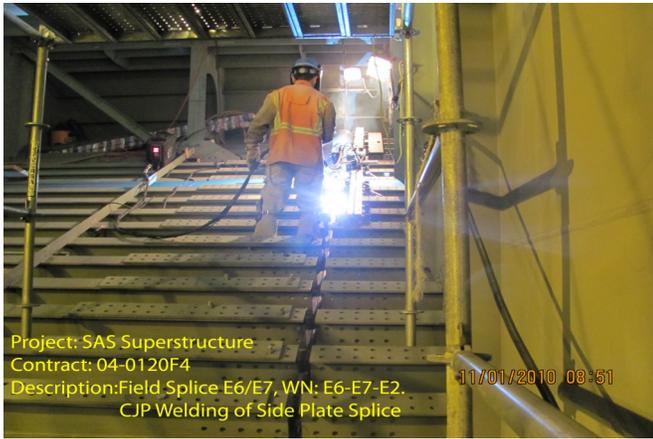
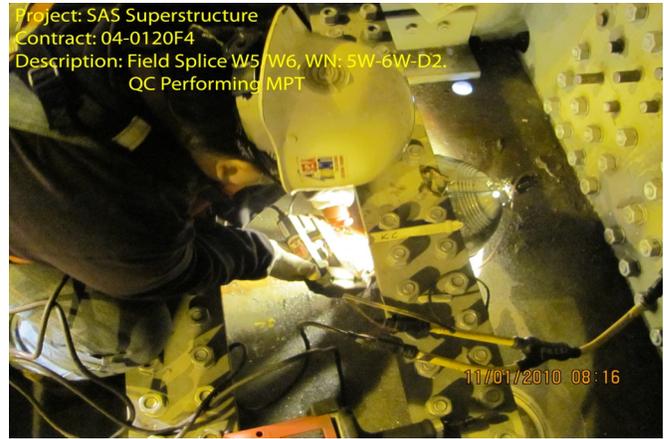
The digital photographs below illustrate the work observed during this scheduled shift.
